AIRCRAFT ACCIDENT INVESTIGATION REPORT

INVESTIGATION REPORT ON AN ACCIDENT INVOLVING GIPPSLAND AEROSPACE (GA 8 - AIRVAN) AIRCRAFT WITH REGISTRATION A2 – AJZ THAT OCCURRED AT SUMELO SETTLEMENT, SOUTH OF MAUN AIRPORT, ON THE 1st JULY 2023.

REFERENCE MTPW/AIG/15/23

Name of Operator	MACK AIR (PTY) LTD
Aircraft Manufacturer	GIPPSLAND AEROSAPCE (MAHINDRA)
Aircraft Name and Serial Number	GA – 8 AIRVAN / GA8-04-059
Investigating Authority	DIRECTORATE OF ACCIDENT INVESTIGATION REPUBLIC OF BOTSWANA

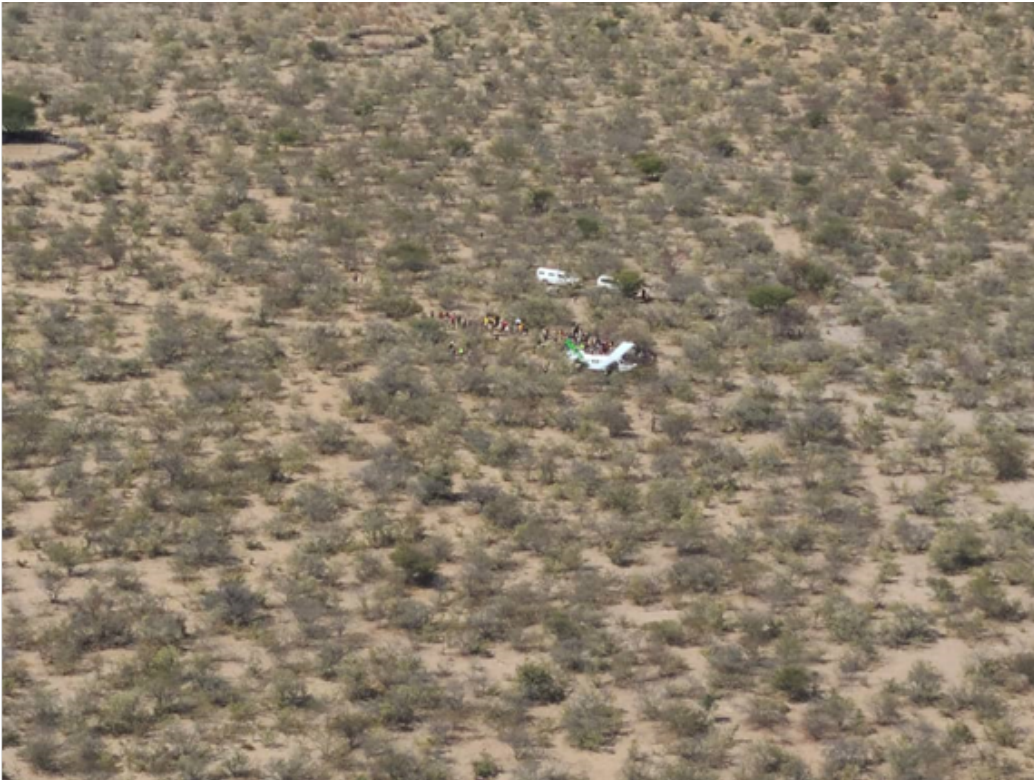
1.3.1 A2 – AJZ sustained very minor damages due to impact with small trees and shrubs. The aircraft suffered dents on the leading edges of both wings, as well as the leading edge of the horizontal stabilizer and the main landing gear fairings. Both taxi lights on the right and left broke. Top and bottom engine leading edge cowlings were slightly broken. The pitot tube got bent and the door step on the pilot side broke.

Figure 1a: Aerial view of A2 – AJZ after forced landing at Sumelo settlement

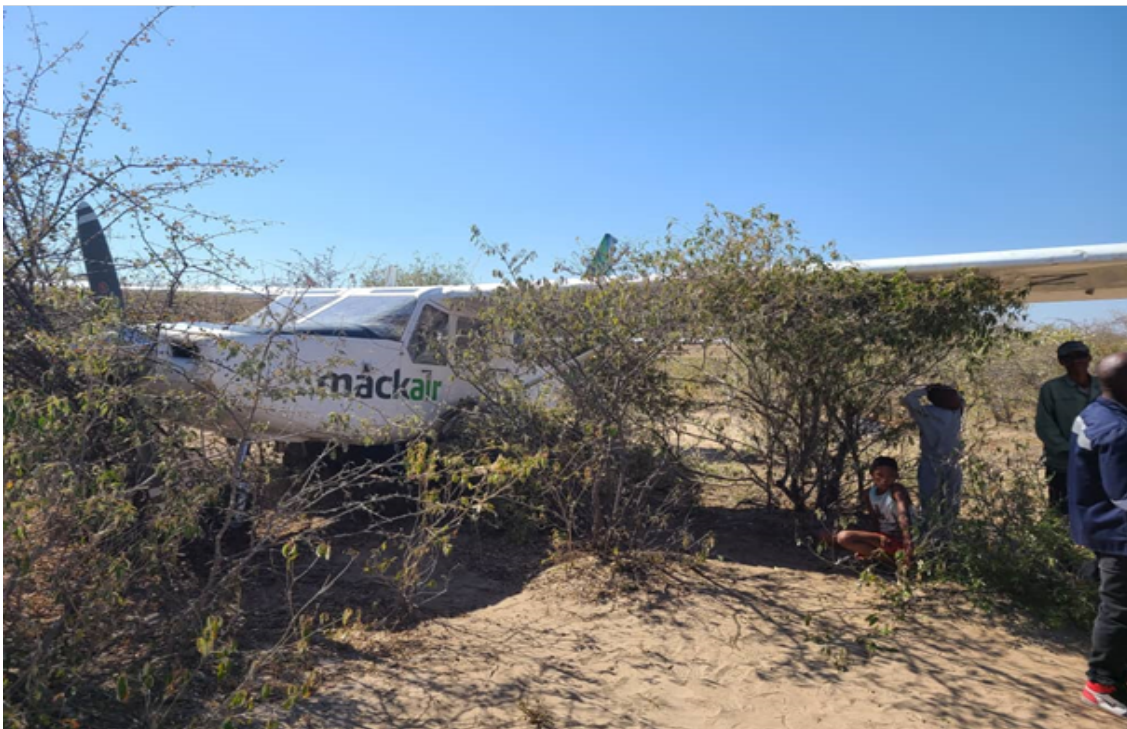
1.12.1 The aircraft wreckage was found positioned by the trees. The wreckage was intact and free from fire. The damage sustained by the aircraft was mainly due to the impact with the tree branches.

Figure 1b: A2 – AJZ forced landed on the bush

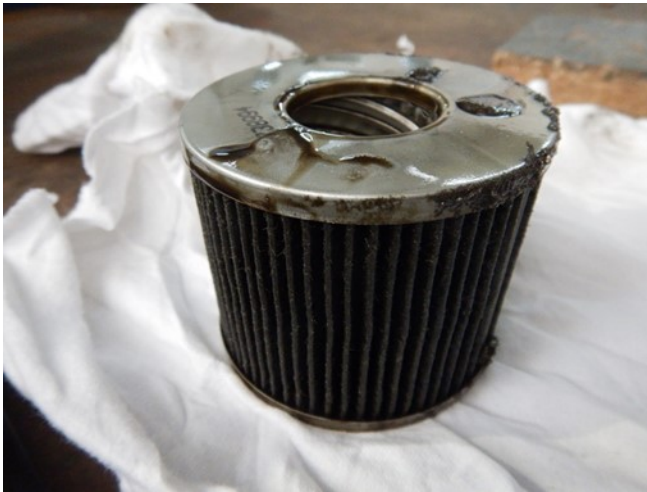
1.16.1 The aircraft engine was taken for an observed laboratory stripping and test analysis. The engine showed signs of discolouration at the cylinder fins surrounding the spark-plugs. The engine oil filter was the first component to be tested. At the time the oil filter was removed from the engine, it was found to be dry with very little oil presence within. **(see figure 2a).**

Figure 2a: Main oil filter removed from the canister during lab testing

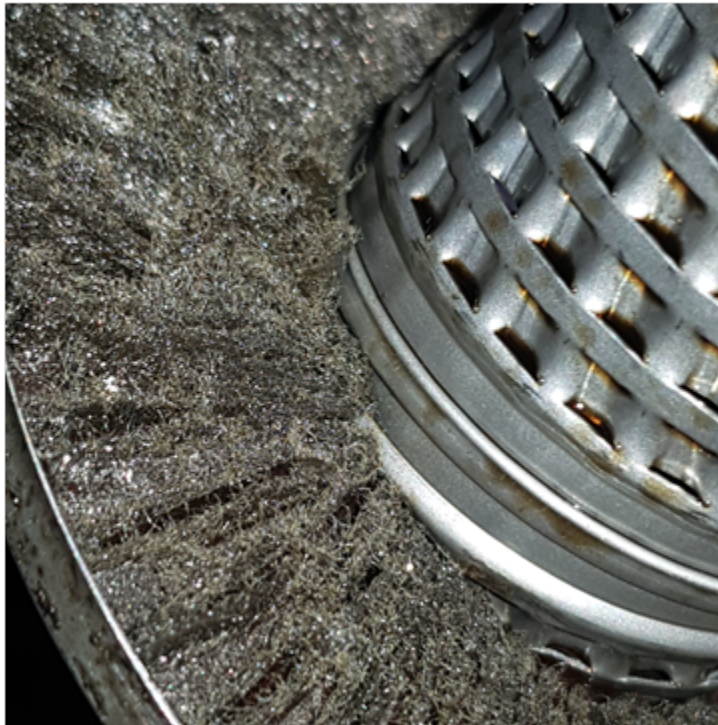
1.16.2 The metal canister containing the engine oil filter was cut open in order to inspect the filter component for debris. The paper filtering component was found dry and littered with shiny particles plastered all over the can. The shiny particles were very fine and minute, more like magnetic iron fillings. **(see figure 2b and 2bb).**

2.1.4 From the oil filter analysis results it was determined that the rate of component wear within the engine were high. The wearing off of the bronze bush occurred at an alarming rate that it reached a critical level. The analysis of debris in the filter revealed plain carbon steel as a major constituent within the

Figure 2b: Cut open oil filtering component littered with shiny metal debris

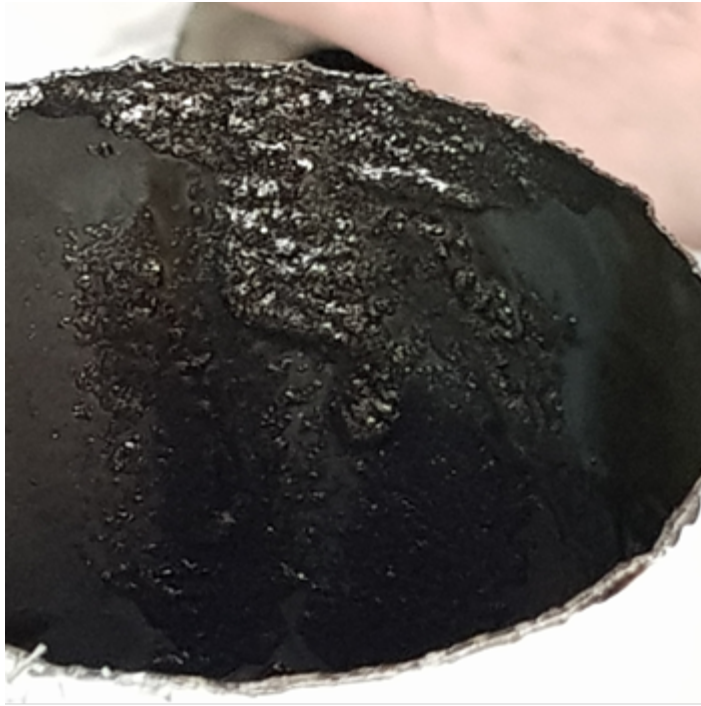
Figure 2bb: Main oil filter canister cut open and exhibiting dried up sludge of oil and some metal debris

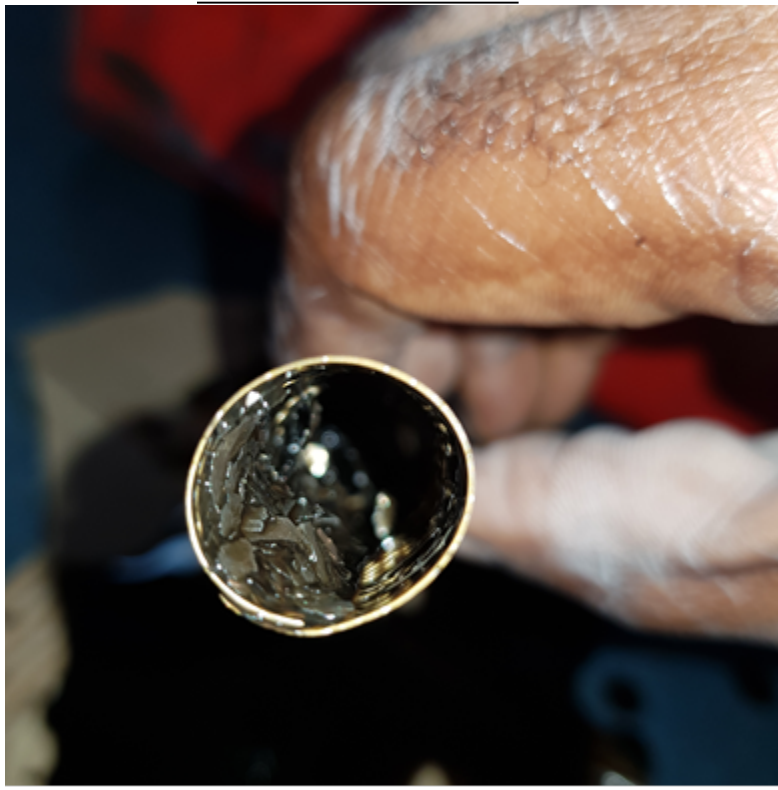
1.16.3 The next component to be tested was the suction oil filter/screen resident within the oil sump. The suction oil filter/screen was found clogged with black rubber like material. In addition, small particles of copper like material were found inside the filter as a second layer of debris clogging the mesh filter. **(see figure 2c).**

3.3.1 The crankshaft oil seal subsequent deterioration due to crankshaft pounding led to its breaking into small pieces that blocked the suction oil screen. This process appears to have been gradual over a period of time. Ultimately, the suction oil screen prevented oil passage to the main oil filter and the engine oil pressure was reduced hence the rise in engine oil temperature.

Figure 2c: Debris clogging the suction filter

- 4.2 It is recommended that oil suction screen inspection must be amongst one of the checks that are carried out frequently after the engine has been subjected to long periods of inactivity. This must also apply to new or recently overhauled engines that are just brought into operation. The results of both main oil filter and the suction screen must be documented for future reference.

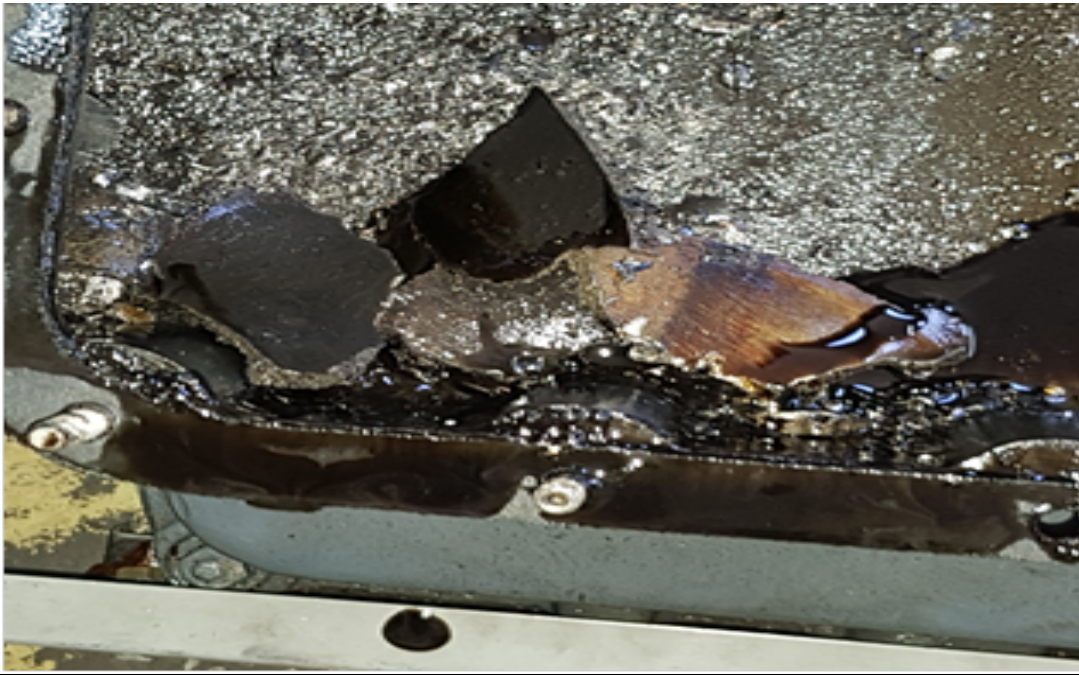
1.16.4 Inspection of the oil sump revealed the presence of metal chips. There were fine to large metal pieces found within the oil sump. A sample from the oil found in the sump was taken for testing and analysis. **(see figure 2d).**

Figure 2d: Oil sump with metal debris of all sizes

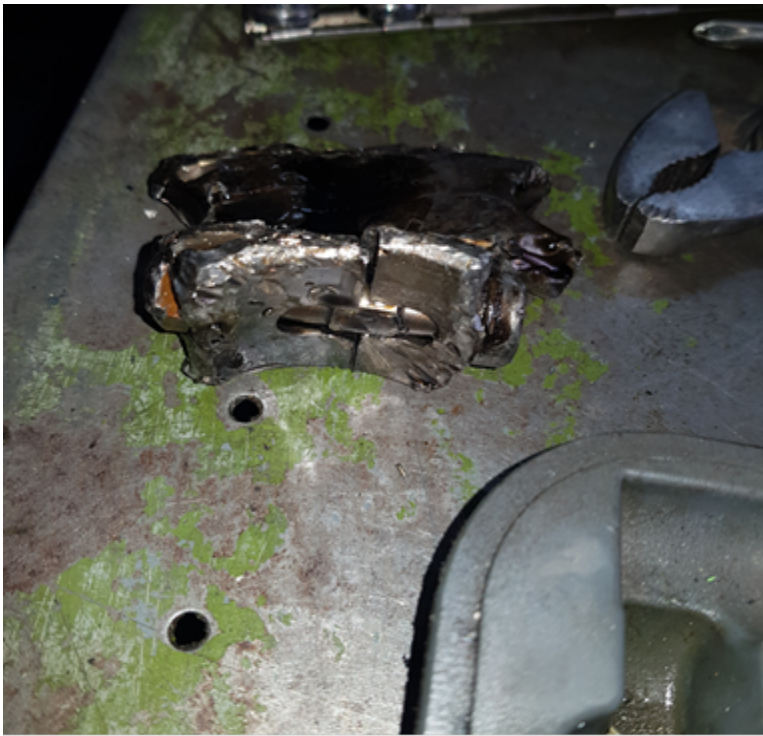
1.16.6 The number 5 piston connecting rod was found broken inside the crankcase. The uncontained movement of connecting rods for pistons 5 and 6 had punched holes at the bottom of the crankcase. A broken piece of a connecting rod cap was found in the oil sump. The nut and bolt used to secure the connecting rod big end were found to be intact on the broken piece. **(see figure 3a, b, c, d, e)**

Figure 3a: Broken off connecting rod big end cap

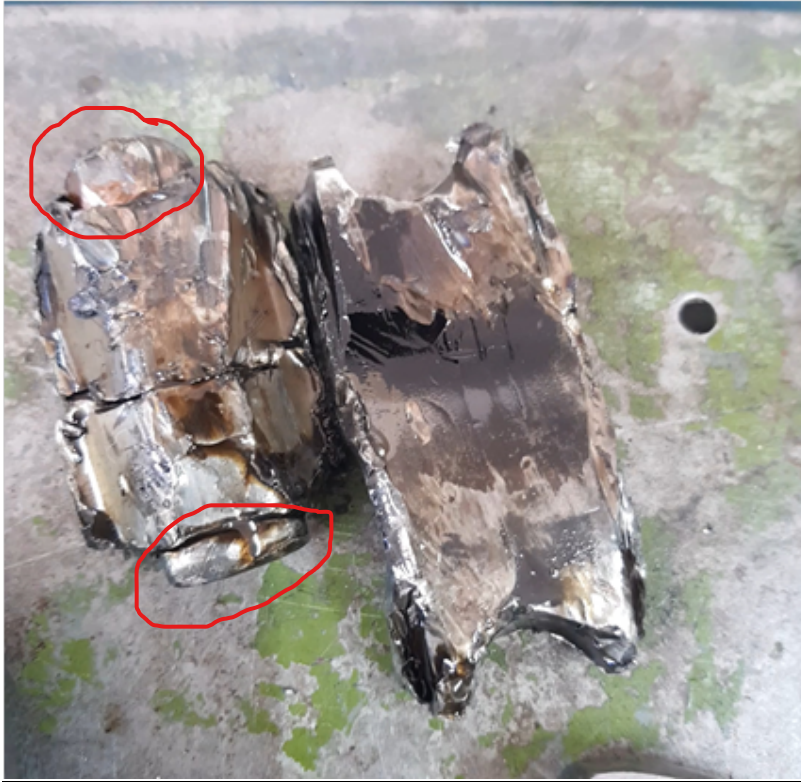
2.1.7 Connecting rod bearings for piston 5 was worn due to lack of lubricant. The connecting rod big end bearing cap of piston 5 failed and ended up being dislodged from the crankshaft. The connecting rod punched through the wall of the crankcase as it was now in an uncontained movement. Hence the crankcase was breached and large metal debris fell into the oil sump below. The 2 failed connecting rods damaged the bottom of both halves of the crankcase causing open holes on the housing. **(see figure 3b, c, d)**

Figure 3b: Broken off big end connecting rod cap (Note that the connecting rod bolt and nut are still intact)

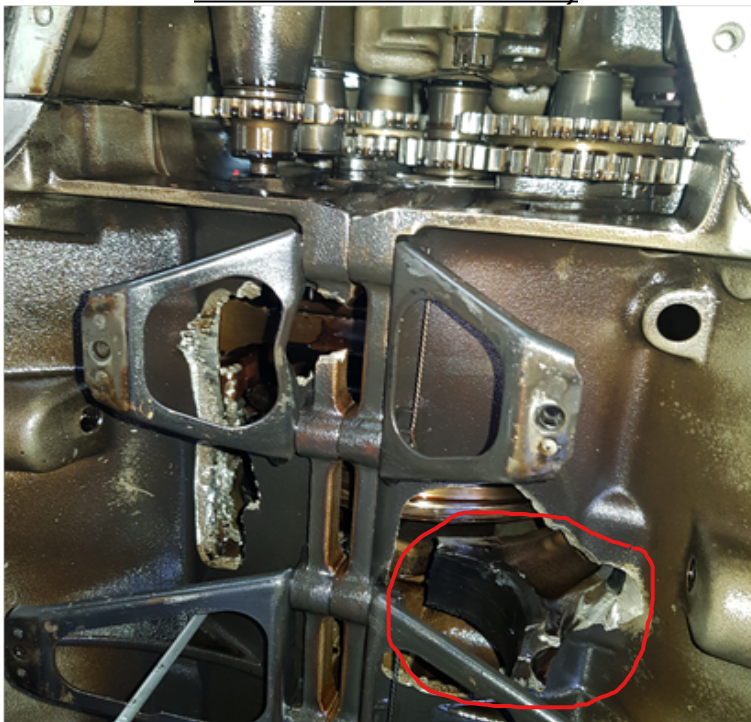
Figure 3c: Broken big end connecting rod #5 piston

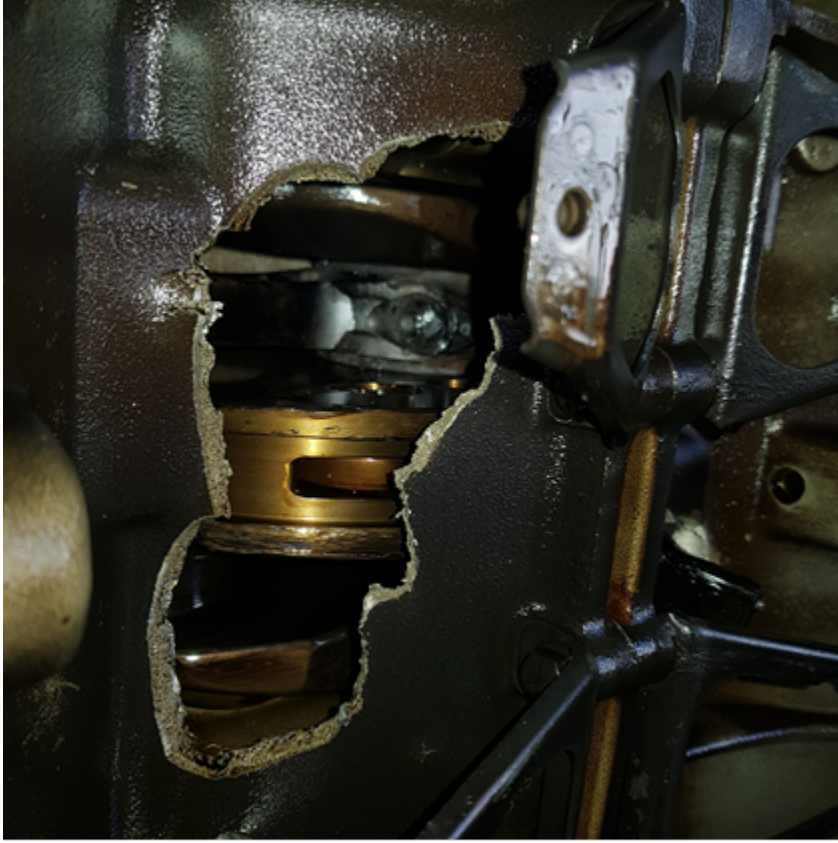
Figure 3d: Crankcase bottom side punched out by uncontained connecting rod

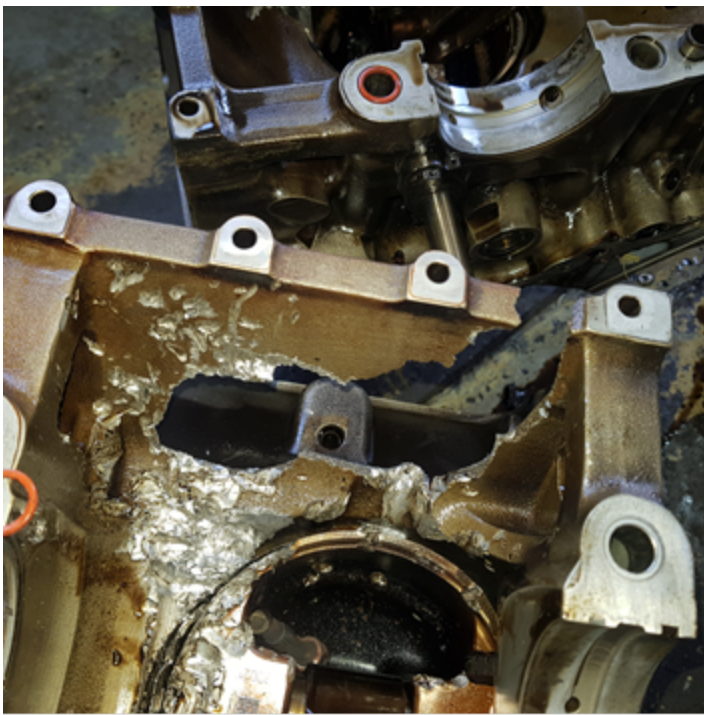
Figure 3e: Separated crankcase revealing the internal damage caused by uncontained motion of the connecting rod

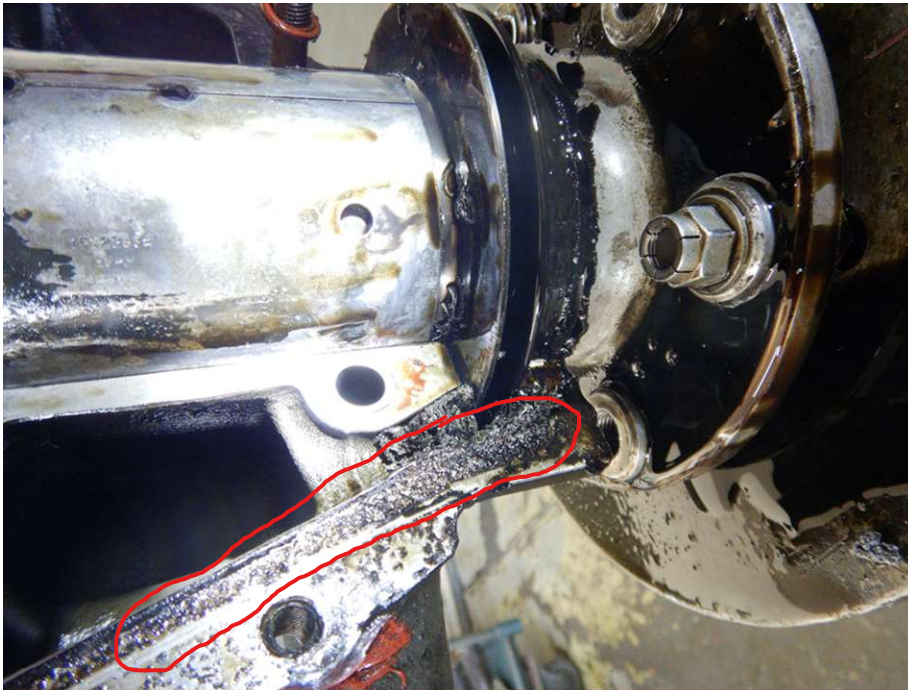
2.1.5 The suction oil screen/filter was found to be clogged with chips of bronze as well as rubber like black material. The rubber like black material appeared to be remnants of a crankcase main bearing oil seal. Upon closer inspection of the crankcase main bearing, it was discovered that the bearings had signs of heat spots/marks and chaffing from metal to metal contact. The oil seal was also affected by this metal pounding leading to its chipping off. Further, there were nicks or scratches on the thrust face due to metal-on-metal contact. Small rubber like particles from a pounded seal were also evident in the front oil drain annuls. **(see figure 4a, b)**

Figure 4a: Sludge made up of metal debris and rubber material collected in the annul

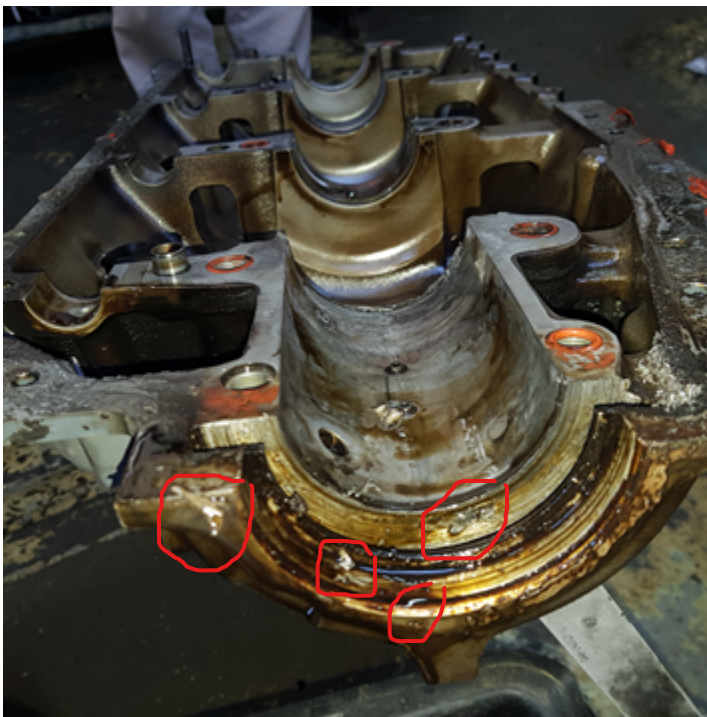
Figure 4b: Damaged thrust face (nicks showing)

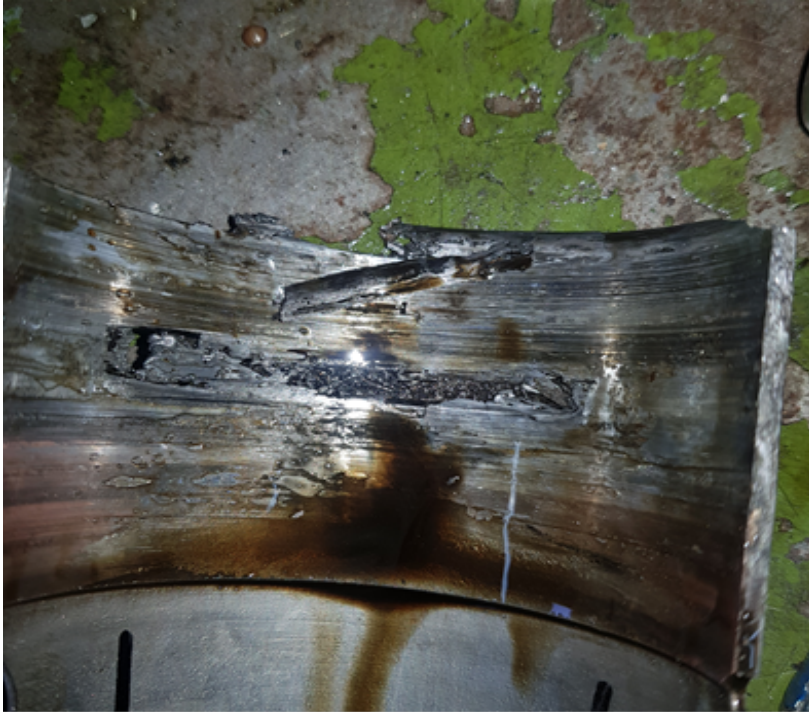
2.1.6 The main bearings also showed signs of wear and tear due to friction with the crankshaft. The resultant chaffed metal particles became trapped between the front crankshaft slinger and the crankcase lower oil drain cavity. It was observed that a considerable amount of metal sludge was still within the crankcase and has not made its way to the engine oil sump. **(see figure 5a, b)**

3.3.2 The obvious impact of oil starvation was crankshaft bearings failure due to excessive heat generated. The main bearing was one of the most affected to the point of wearing off (chaffing) resulting in its fine metal chips clogging not only the engine oil drain annuls but the oil suction screen as well. As more bearings failed the connecting rods caps disintegrated due to excessive heat and breached the crankcase.

Figure 5a: Main bearing with broken metal pieces due to metal on metal contact (chafing)

- 4.1 It is recommended that the storage of engines during an extended period of inactivity or during transporting to client after shop overhaul must adopt measures aimed at ensuring that the oil film between the main bearings and the crankshaft is not displaced. The loss of lubrication is detrimental to the crankshaft main bearings and the crankshaft as it will lead to metal on metal contact, resulting in engine failure due to excessive heat generation.

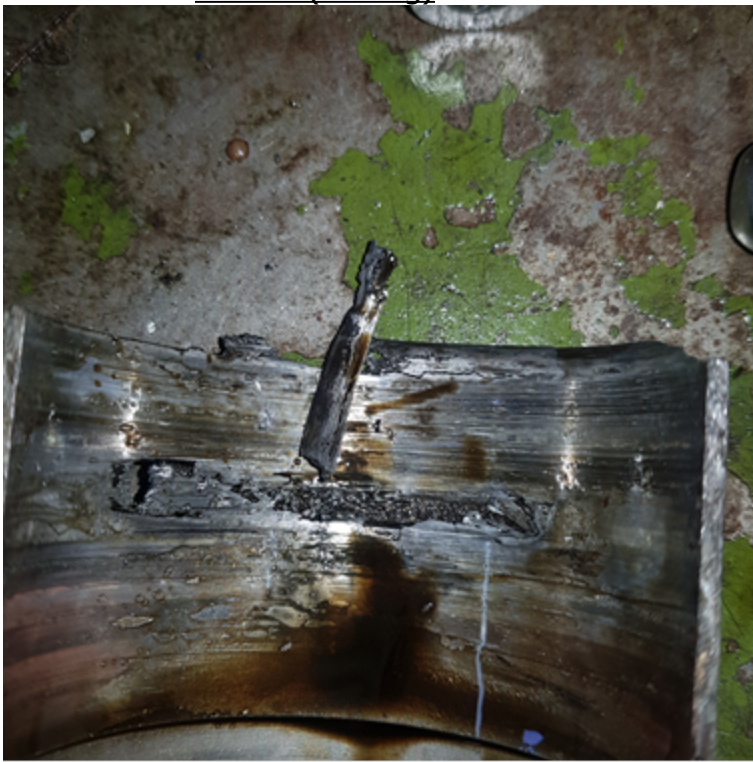
Figure 5b: Metal debris of broken main bearing

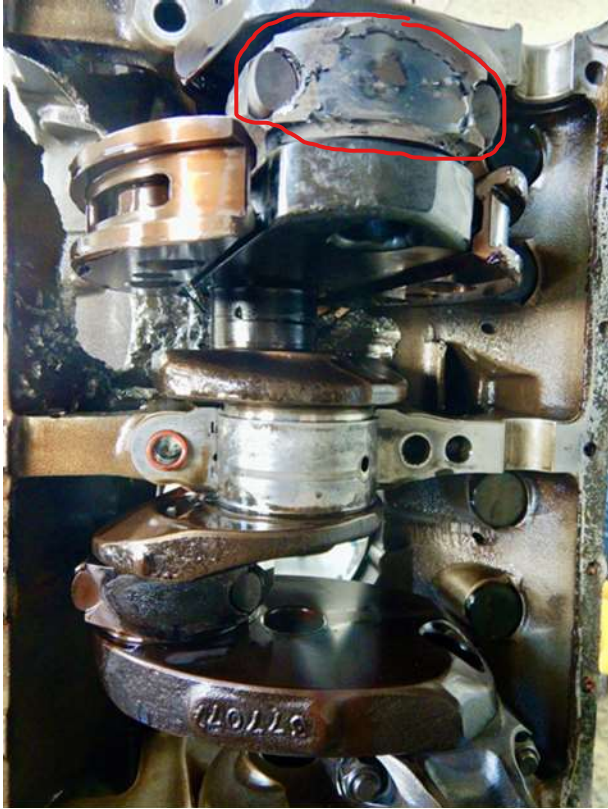
Figure 6a: Evidence of severe heat damage
