AIRCRAFT ACCIDENT INVESTIGATION REPORT

INVESTIGATION REPORT ON AN ACCIDENT INVOLVING MAULE 5-210C AIRCRAFT REGISTERED ZS – JIP THAT OCCURRED ON THE 28th MAY 2023 AT LIMPOPO VALLEY AIRFIELD – MASHATU, BOTSWANA.

REFERENCE MTPW/AIG 12/23

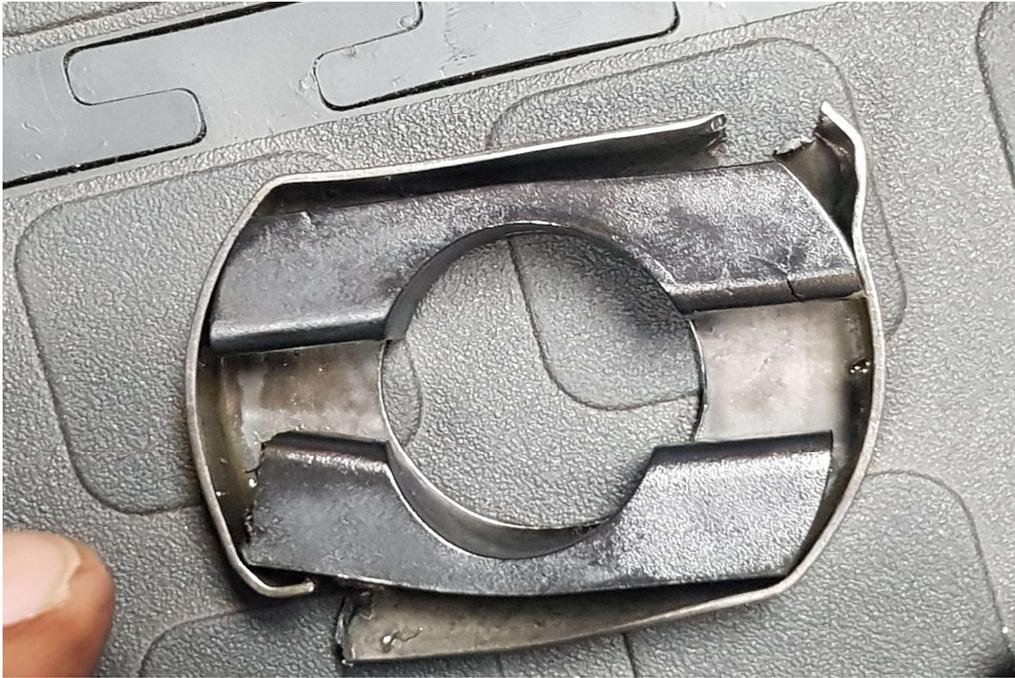
- 1.16.2 The right-hand side magneto did not turn completely.
- 1.16.3 After disassembly of the magnetos it was found that the drive cushion on the left magneto was deformed completely. (see **figure 1**)

Figure 1: Damaged magneto retainer bushing

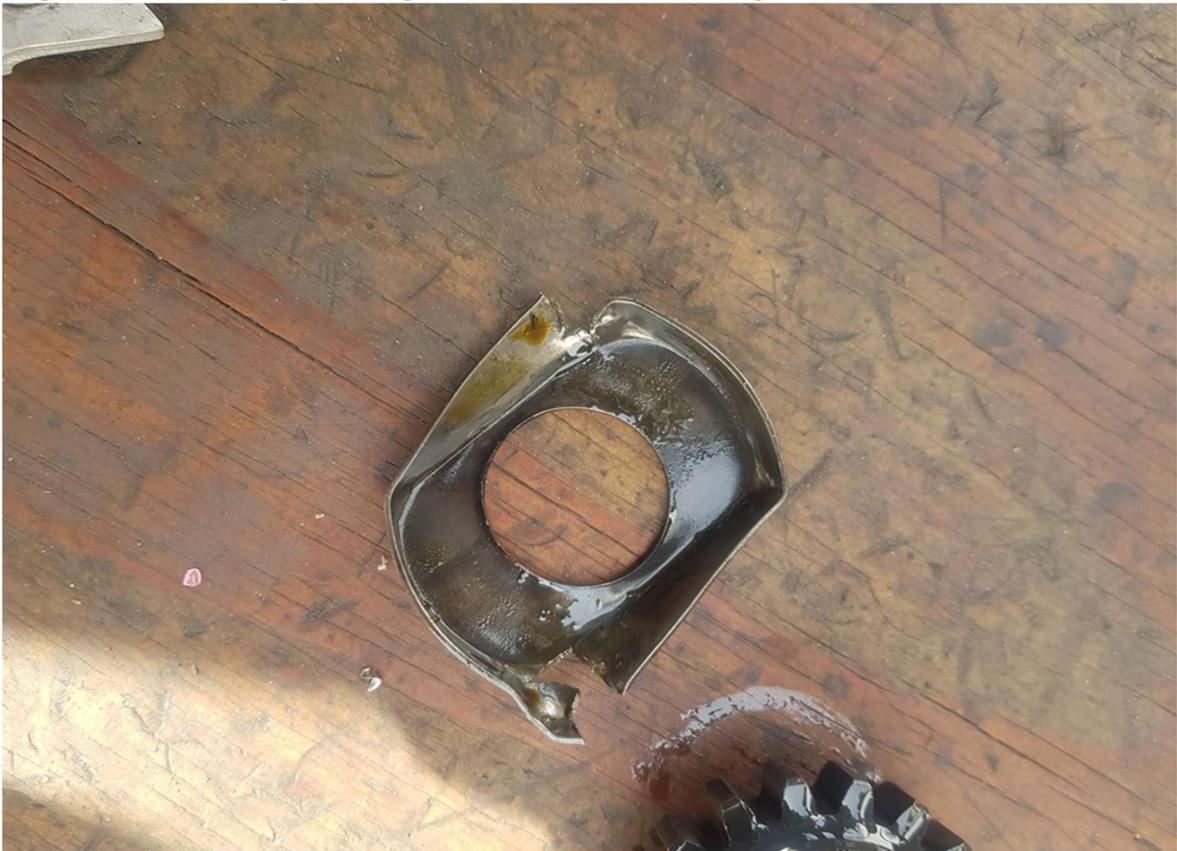
- 1.16.4 Also, the left magneto gear retainer assembly was damaged by way of shearing at the corners and it was completely deformed. (see **figure 2, 2a**)

Figure 2: Damaged magneto retainer (top view)

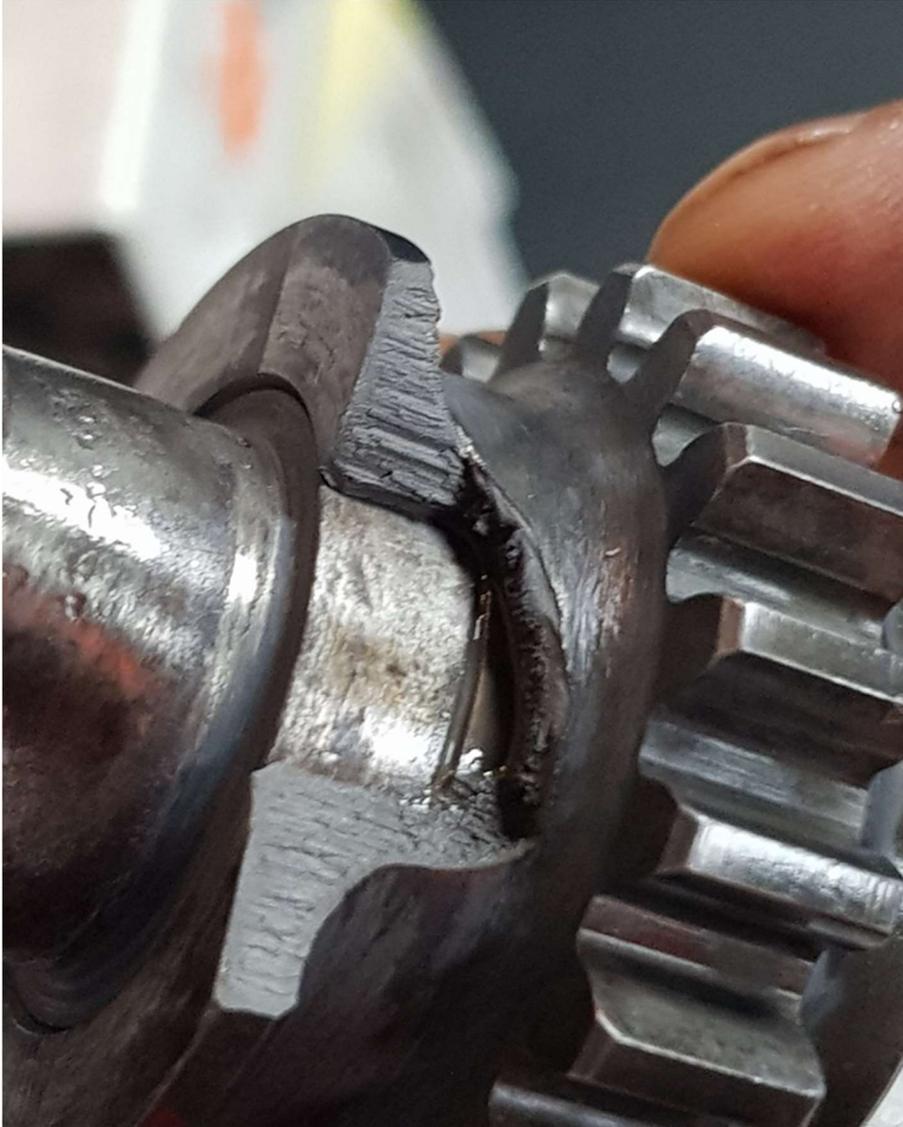
- 1.16.5 The sleeve of the left magneto drive gear had big chunks of metal pieces broken off in more than one place. (see **figure 3 & 4**)
- 1.16.6 The right-hand side magneto distributor gear was found with broken gear teeth. (See **figure 5**)

Figure 3: Magneto drive sleeve with a big metal chunk broken off.

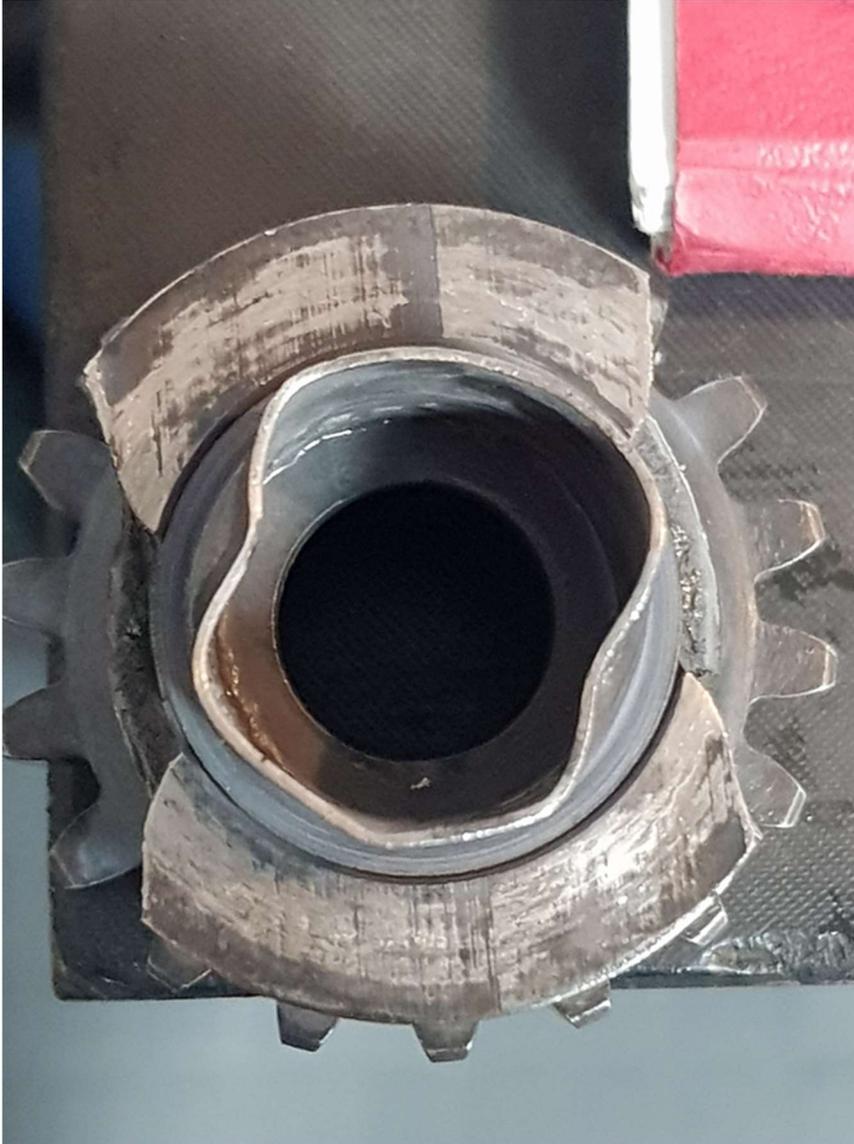
Figure 4: Top view of the left magneto drive sleeve broken in two places.

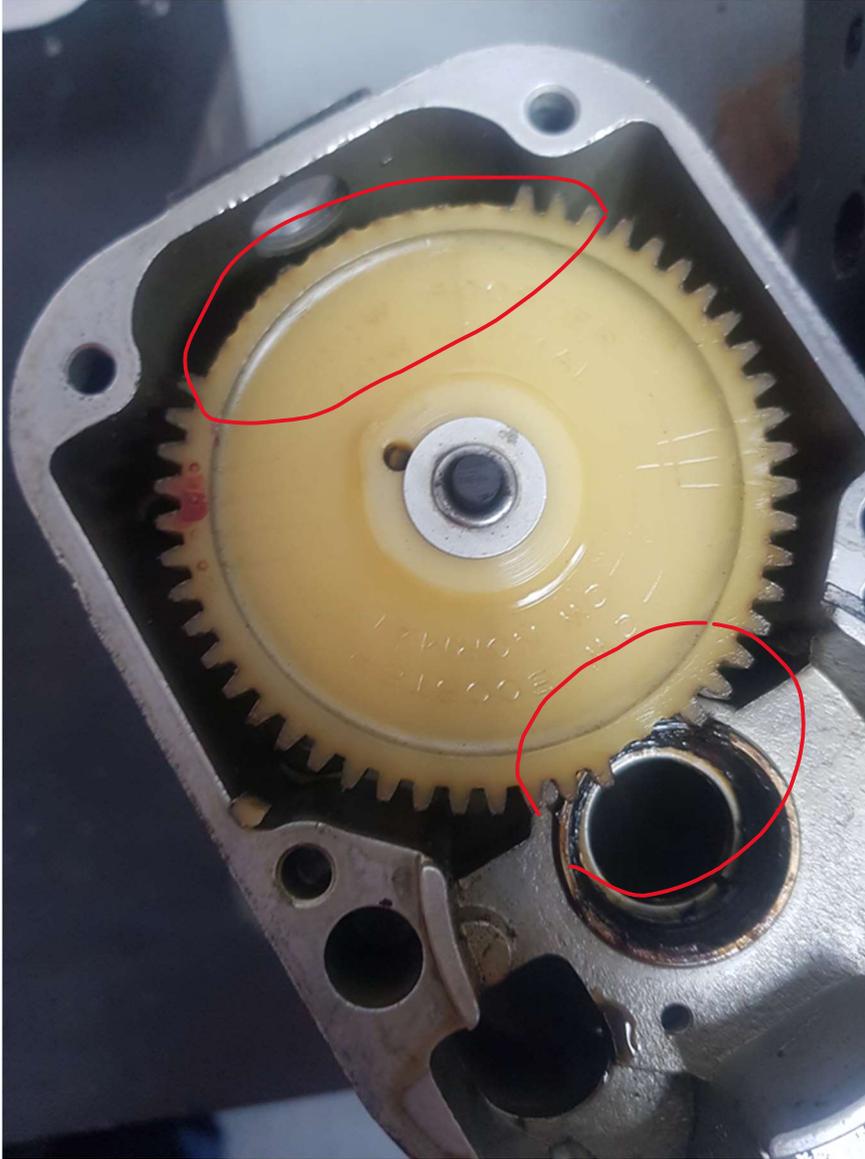
2.8 The scenario above led to failure of the right magneto. The interference of a drive sleeve metal piece caused the engine to abruptly stop running and this adversely affected the right magneto. As a result of sudden stoppage, the right magneto which was functioning properly broke a considerable number of distributor gear teeth that were linked to the crankshaft. This left the aircraft engine with no power source at all.

Figure 5: Right hand magneto distributor with broken gear teeth at the top and bottom

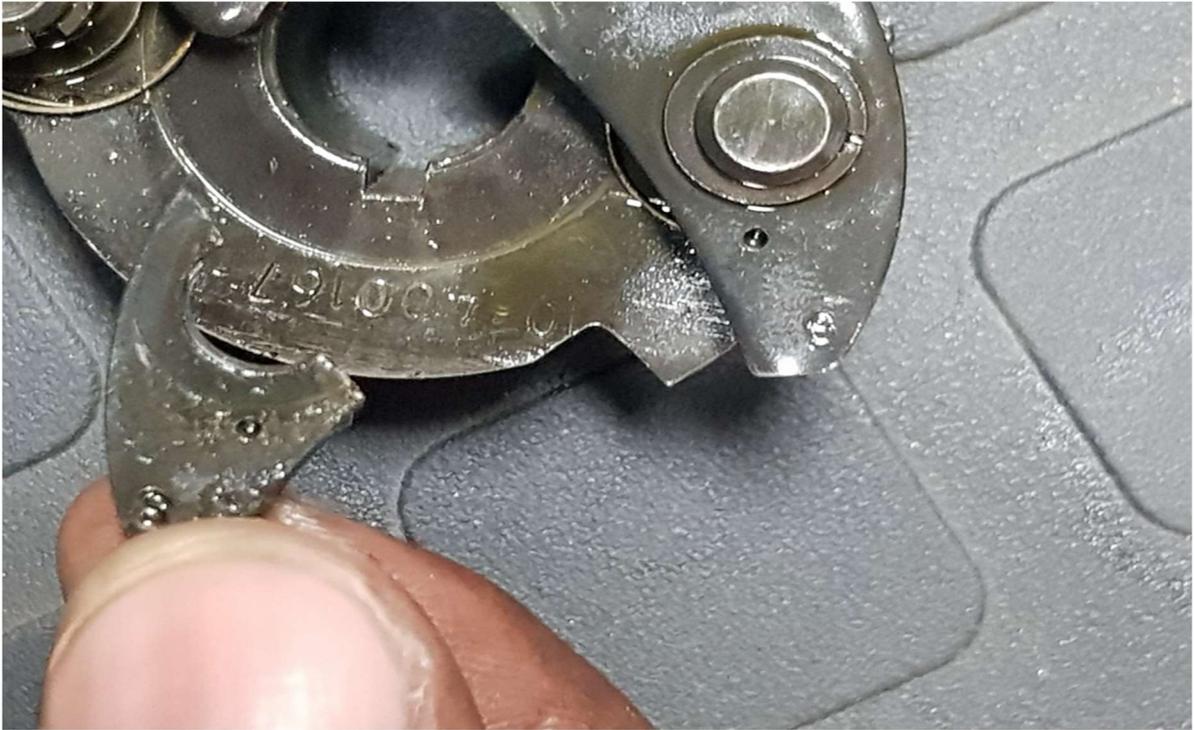
- 1.16.9 The left magneto impulse coupling flyweight was found broken into two (2) pieces. (see **figure 6**)

- 2.4** Failure of the left magneto impulse coupling flyweight resulted in its splitting into two pieces at the pivot axle led the magneto to cease.
- 2.5** The sudden stoppage caused failure of the magneto drive gear sleeve linked to crankshaft gear as the torque on the crankshaft gear was far too excessive. The magneto drive gear sleeve broke in more than one place.
- 2.6** The broken pieces of a drive gear sleeve fell in between the gears linking the alternator with the engine. Alternator drive gear teeth exhibited signs of minor cracks (chipped edges) due to the presence of foreign metal pieces that interfered with the crankshaft/alternator gear motion. The alternator drive shaft ended up bent due to interference by the metal piece.
- 2.7** ZS – JIP lost the power sources as the left magneto and the alternator failed in operation.

Figure 6: Left magneto impulse coupling flyweight broken into 2 pieces at the axle

3.1 A safety recommendation is thus made which requires immediate compliance with the mandatory service bulletin by Teledyne Continental Motors on inspection of riveted impulse coupling and stop pins by users of magnetos using the Bendix magnetos that use riveted impulse coupling flyweights.

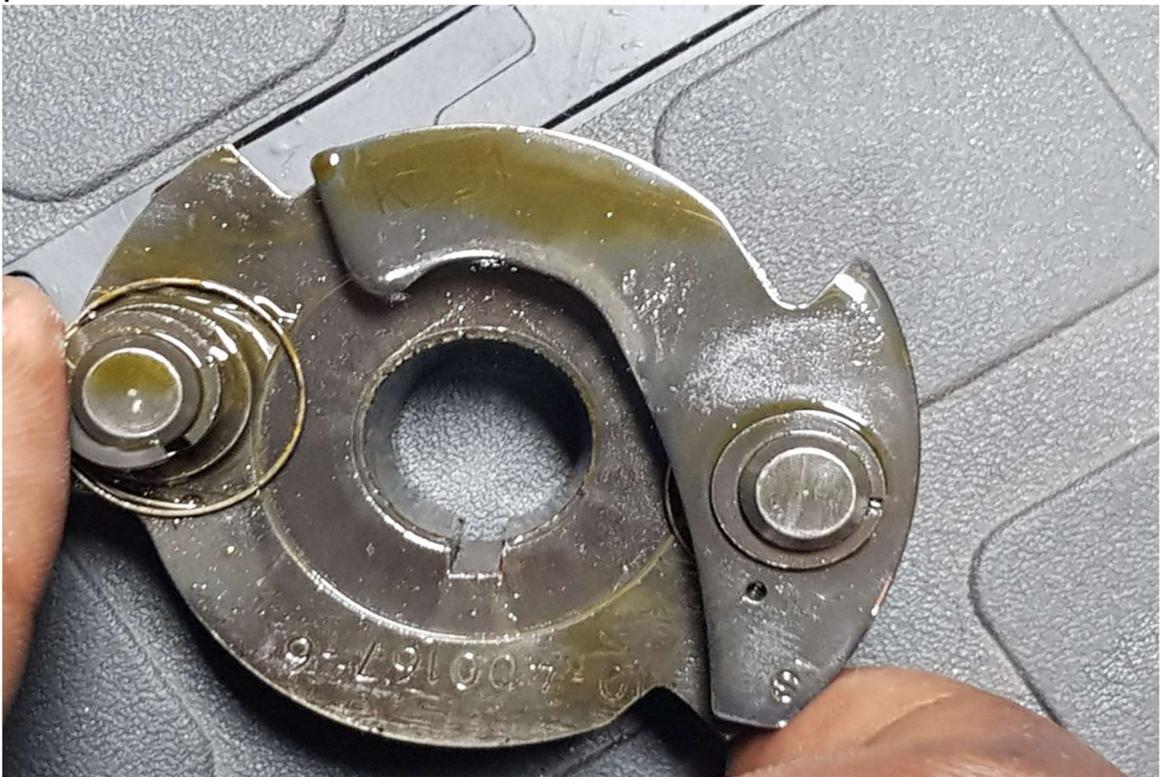
- 2.1** The left magneto ceased in operation leading to the magneto drive sleeve pieces breaking off. The sudden stoppage of the magneto was caused by an impulse coupling flyweight that broke into two pieces inside the magneto.
- 2.2** The pieces of a broken magneto drive sleeve fell off and got trapped between the alternator gear drive leading to cracks on the alternator gear teeth as well as bending the alternator shaft.
- 2.3** The right magneto ended up with broken distributor gear probably due to the fact it was still in operation when there was a sudden stoppage of the engine.

Figure 6a: Left hand magneto impulse coupling missing a flyweight which broke into two pieces.

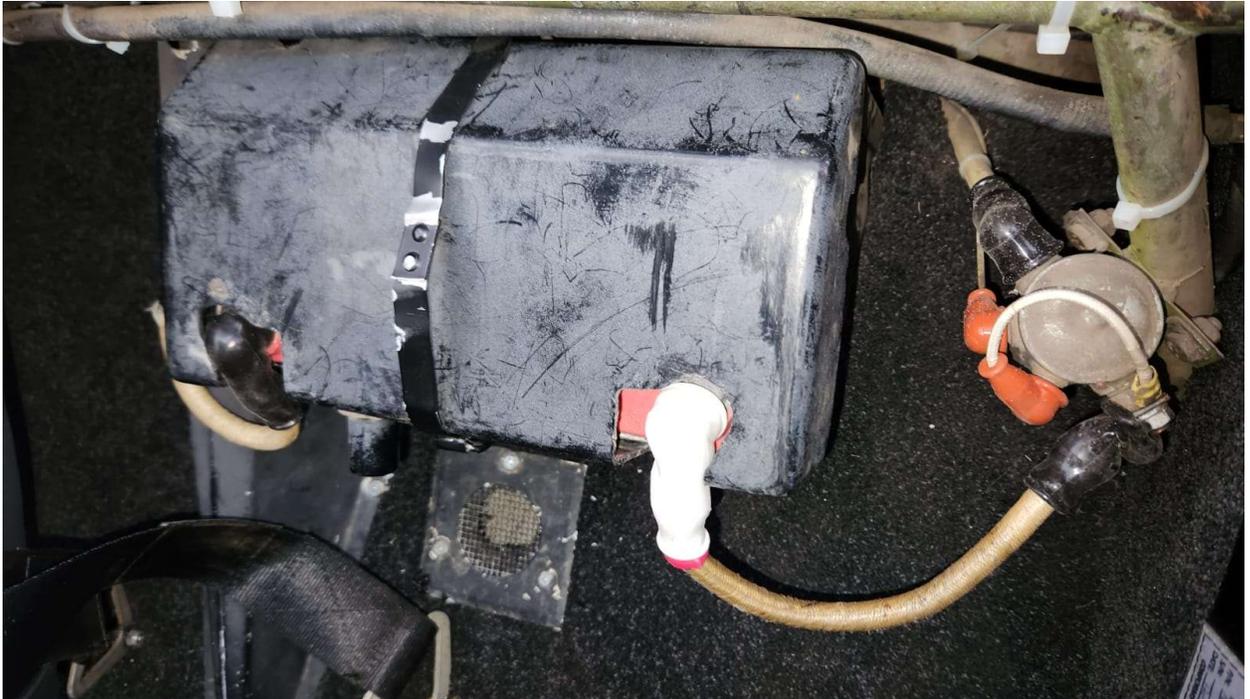
2.11 The location of the battery under the crew seat contributed to the fire that broke out from that area since the battery was a source of spark to the fuel from broken and leaking fuel lines.

Figure 7: A pre – accident pictorial showing the battery location under the crew seat.

3.2 It is recommended that positioning of a battery under the crew seat be revised as it could pose risk to the crew at crucial times of aircraft operation.

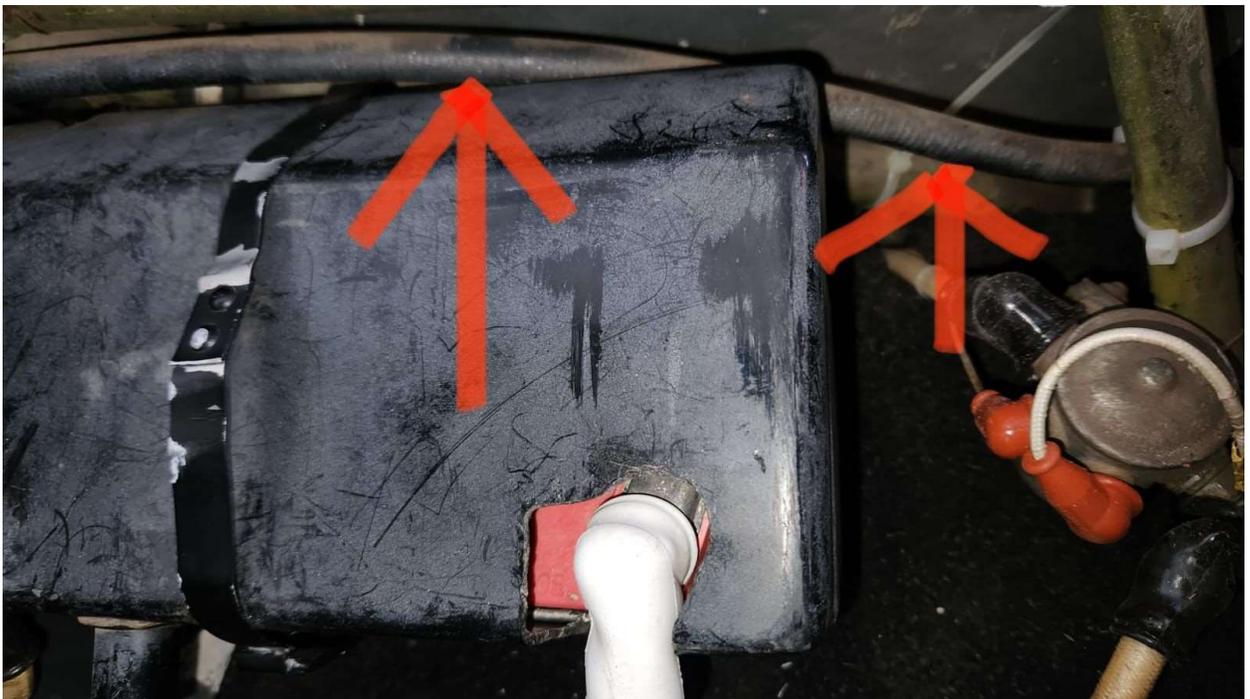
2.10 The fuel cross-feed lines passing underneath the crew seat were also affected by the crash impact on the aircraft underbelly as the collision resulted in damaged fuel lines and fuel leakage. (**see figure 7, 7a**)

Figure 7a: Illustration showing a fuel line passing above the battery housing

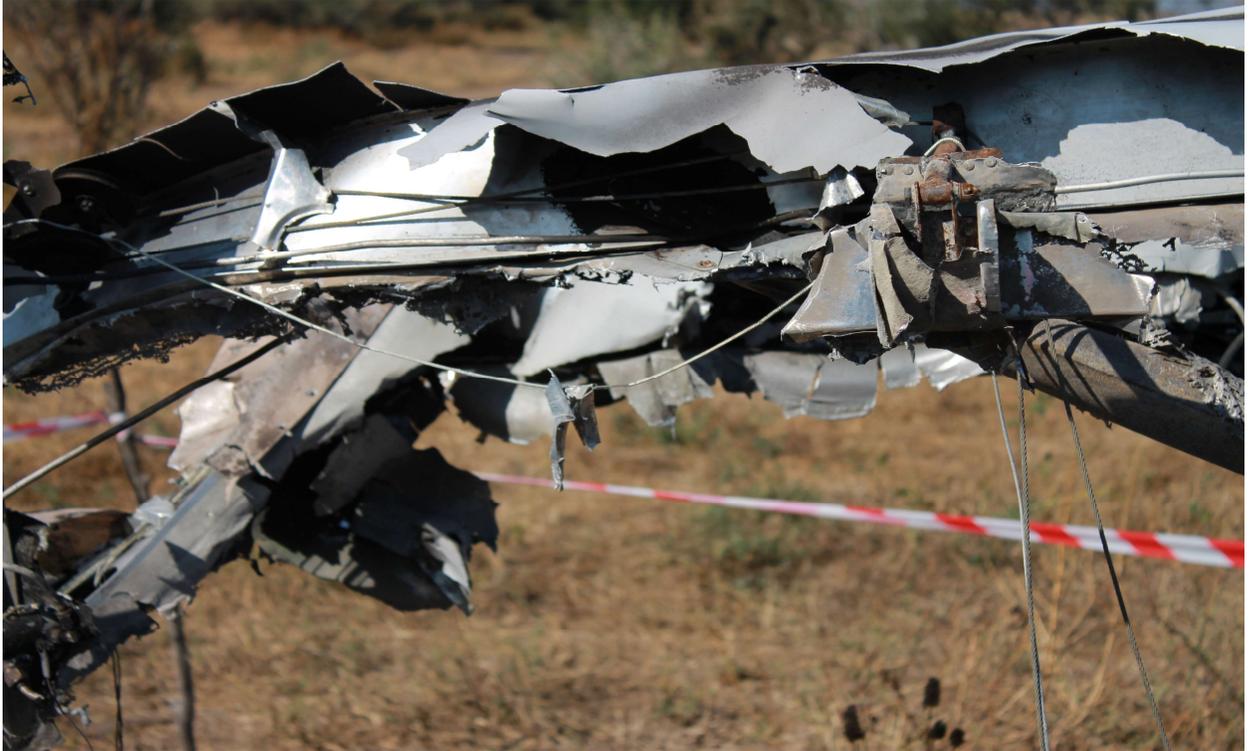
- 1.12.2 The left auxiliary fuel tank fell off the wing structure onto the ground next to aircraft *due to complete burn-out* of the material comprising the wing.

Figure 8: Left wing with the auxiliary wing tank fallen off due to fire

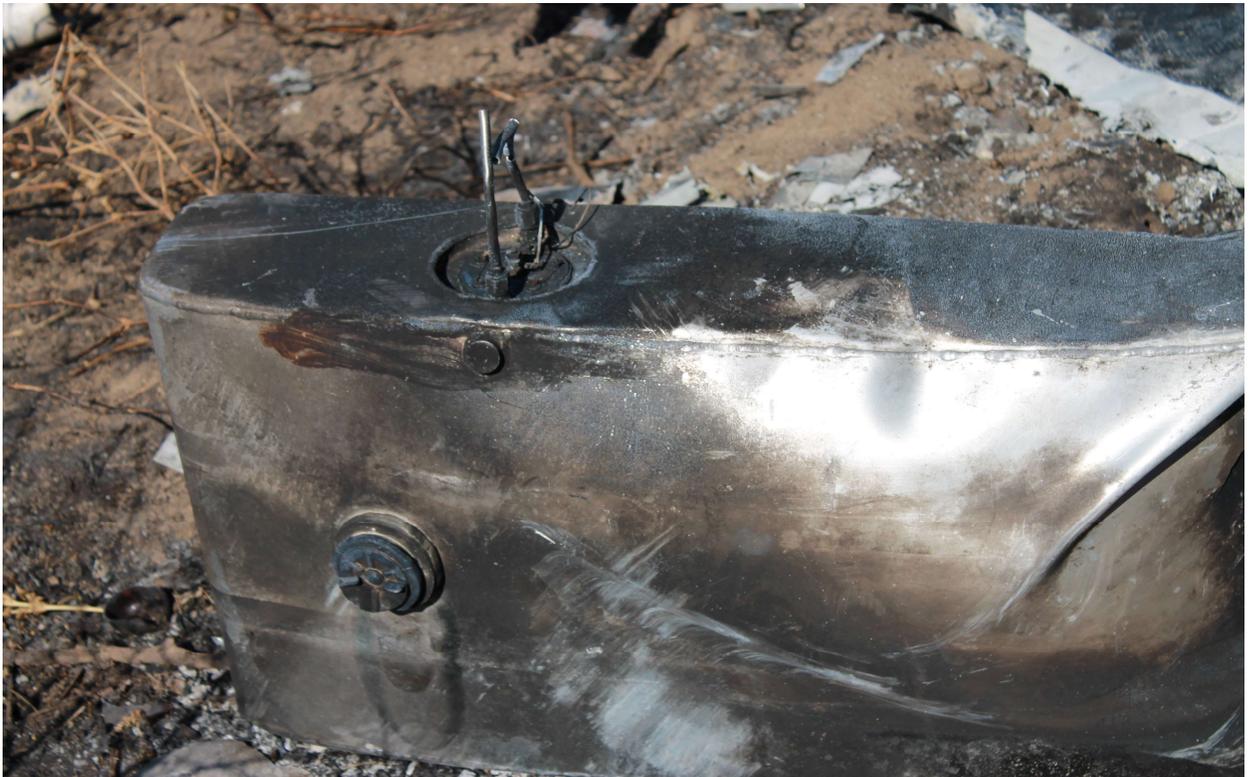
Figure 8a: Fallen off left auxiliary fuel tank.

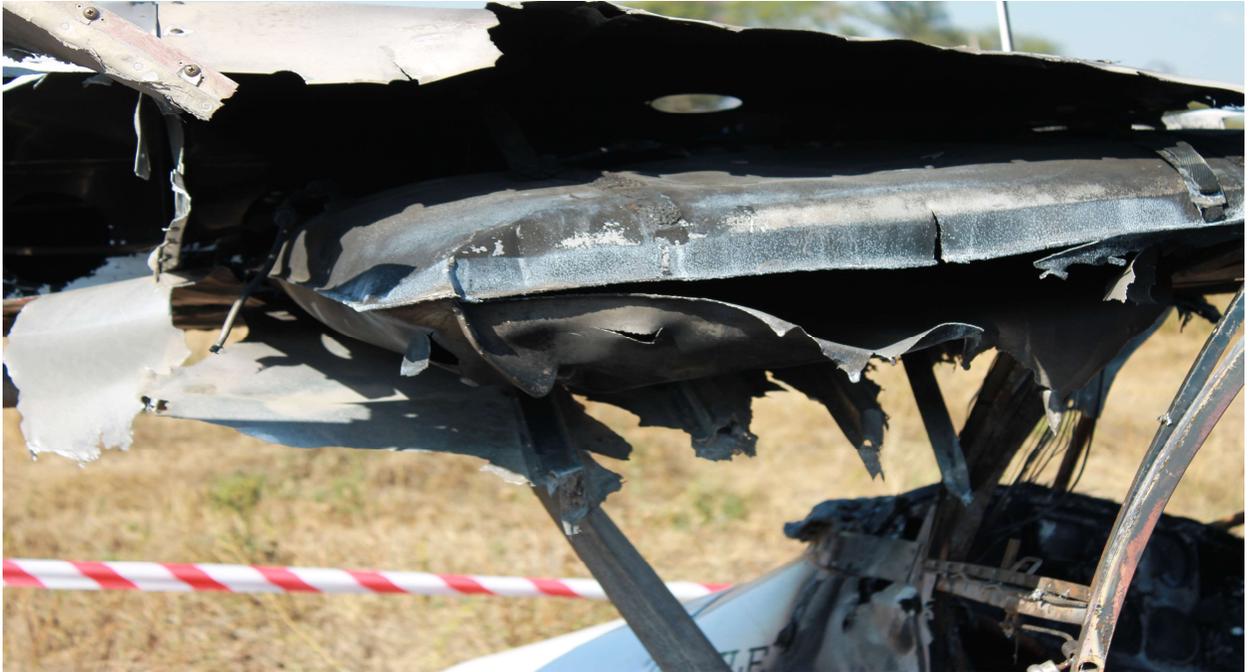
Figure 8b: Illustration of a left main fuel tank that exploded due to post impact fire.

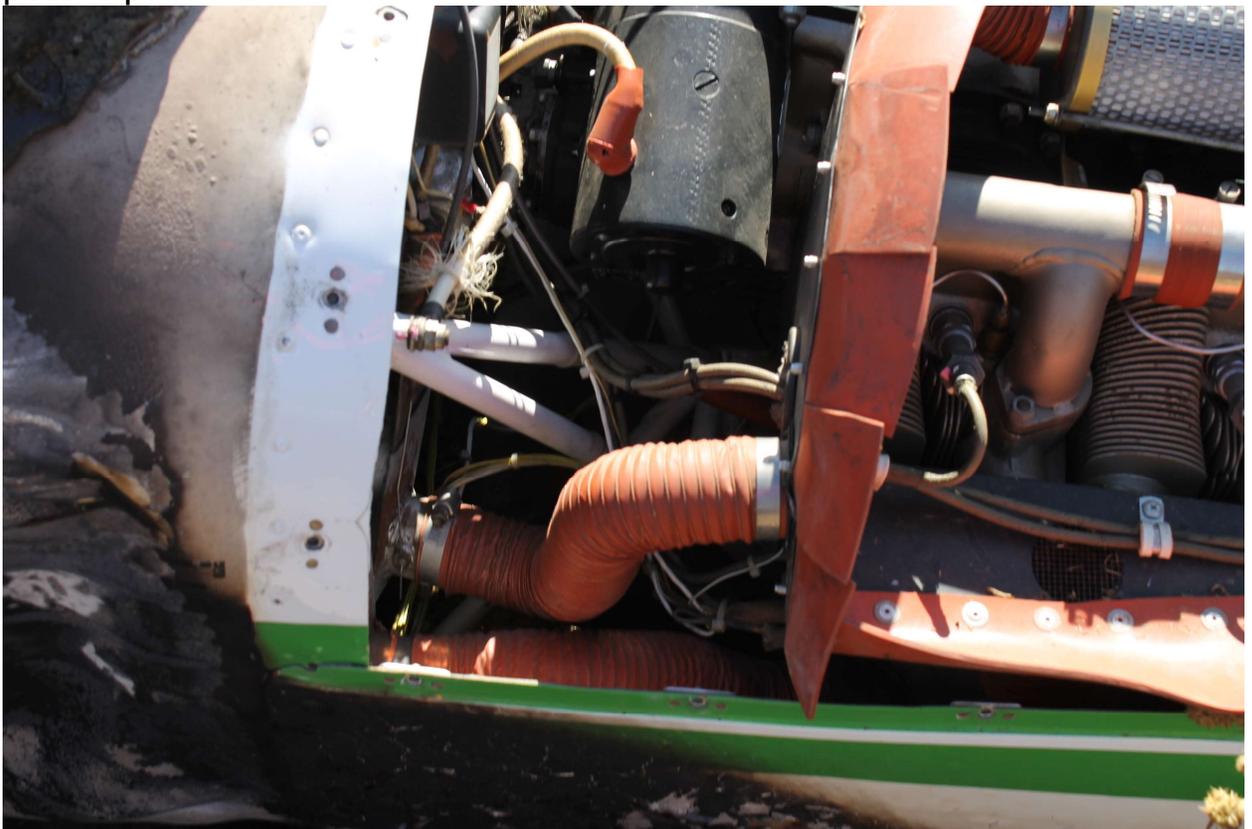
Figure 9: Illustration depicting that the engine was not affected by the post impact fire.

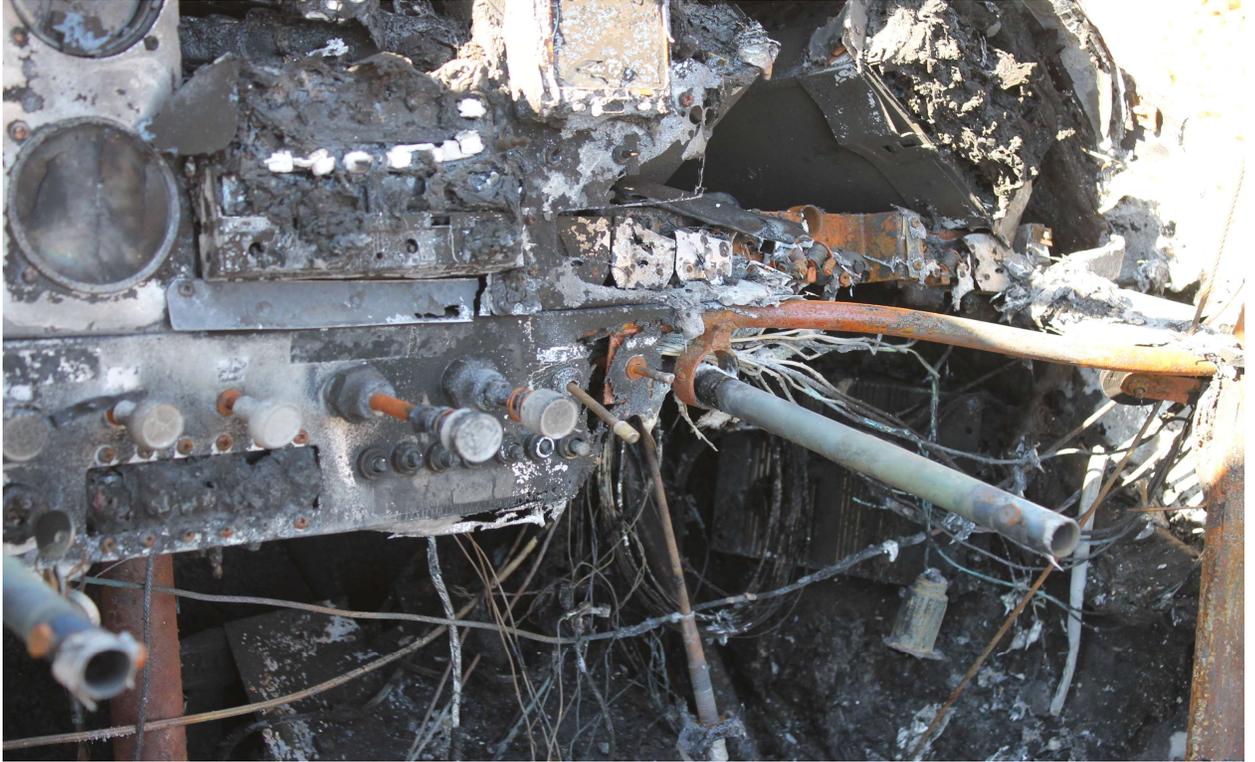
Figure 10: The view of the cockpit post impact fire which was concentrated aft of the firewall.

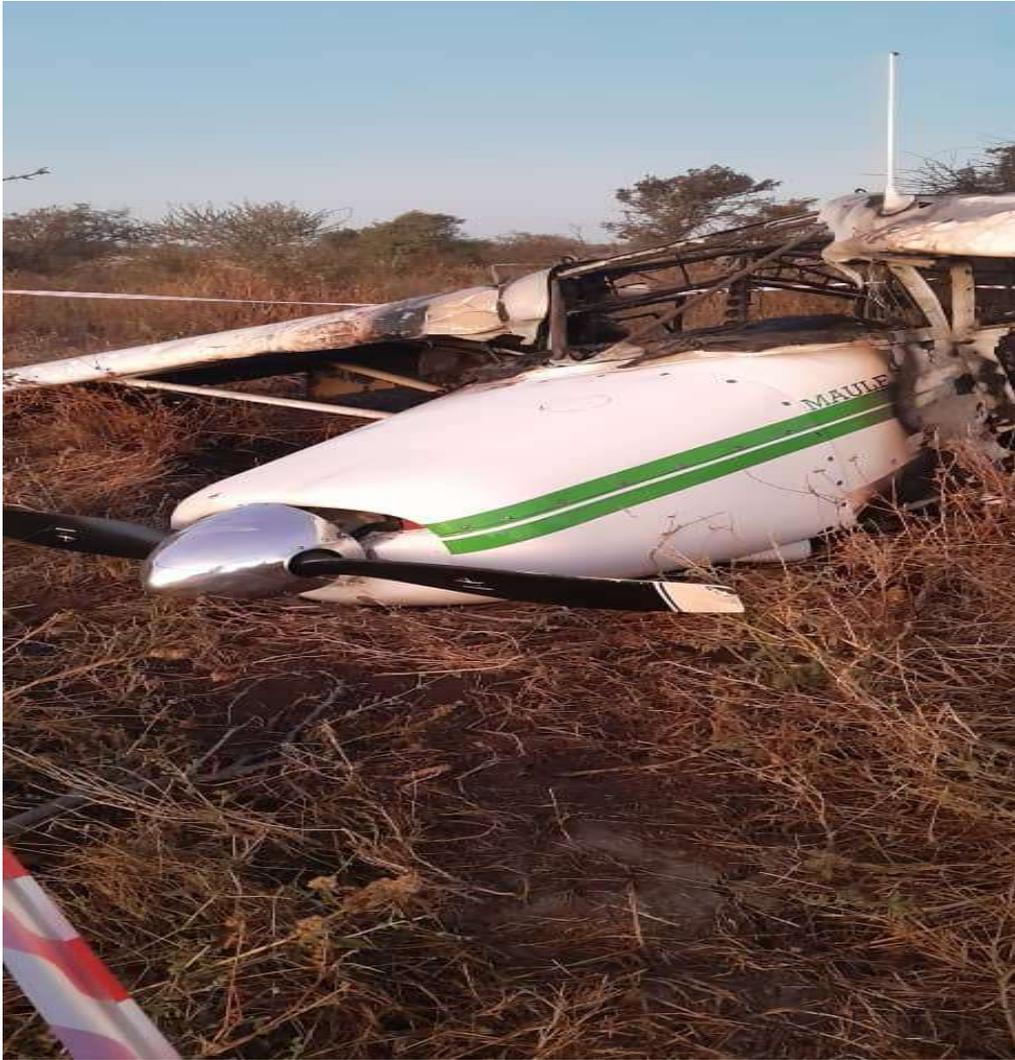
Figure 11: The aircraft nose survived the fire blaze.

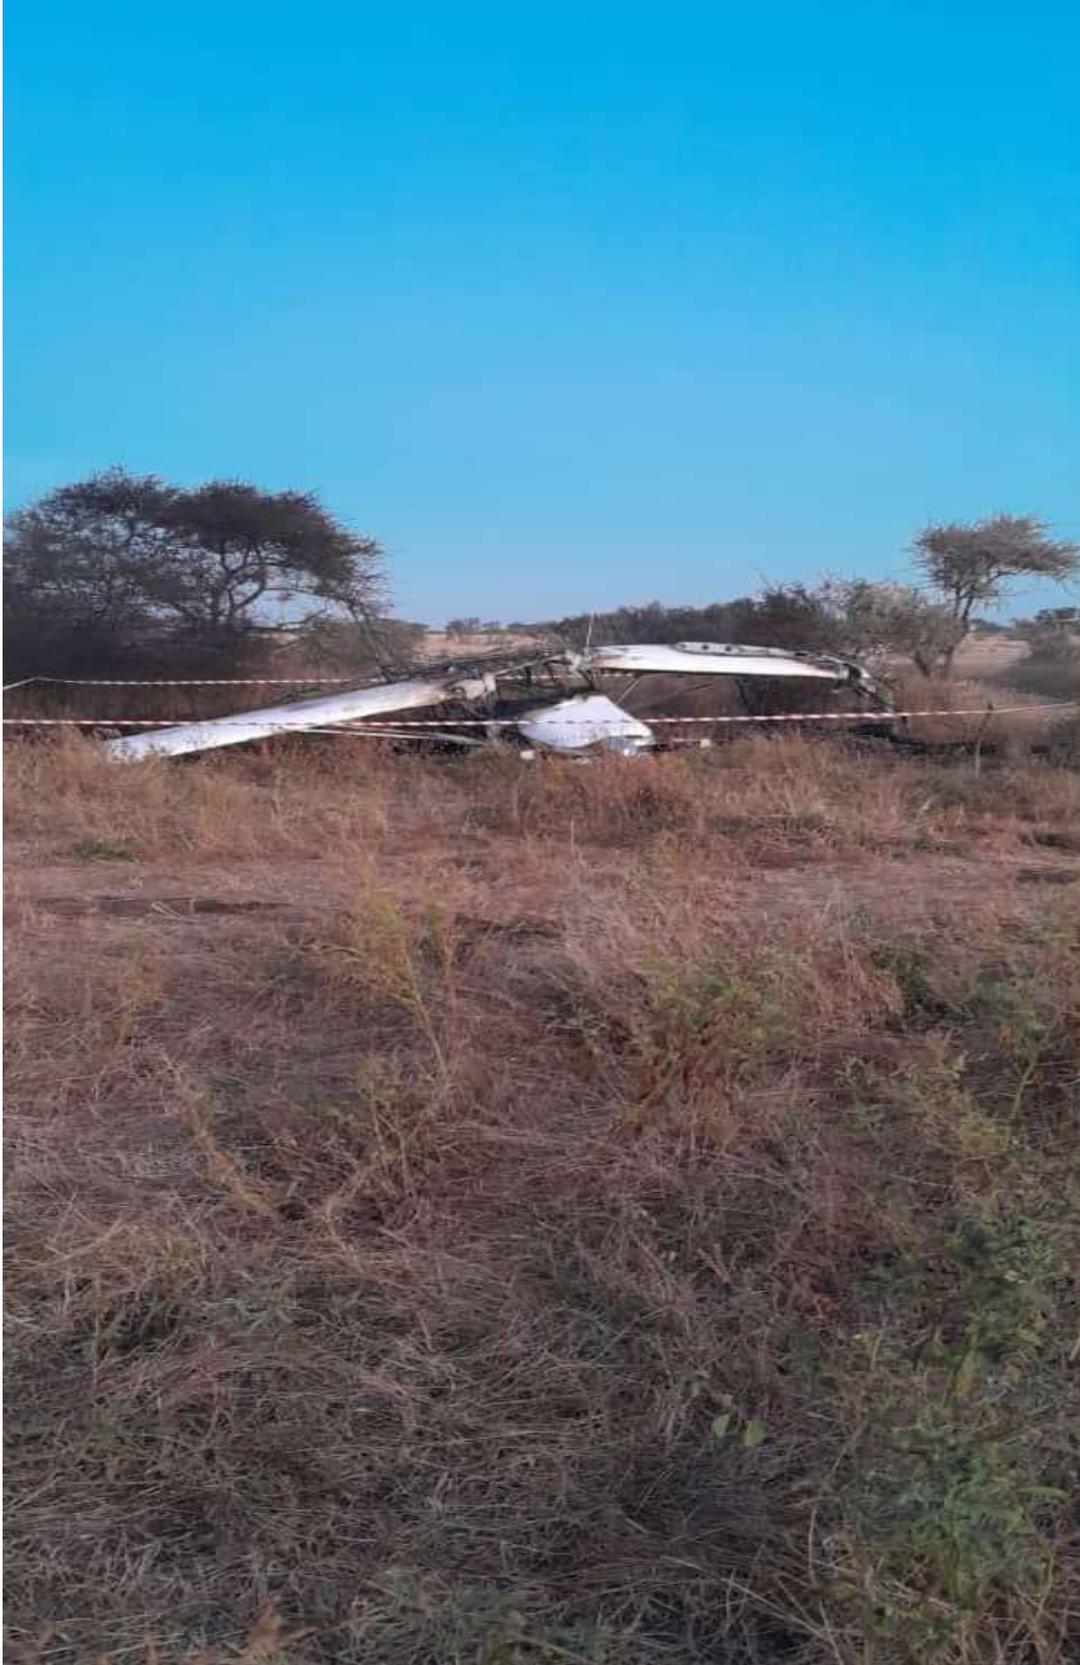
Figure 11a: Front view of the wreckage

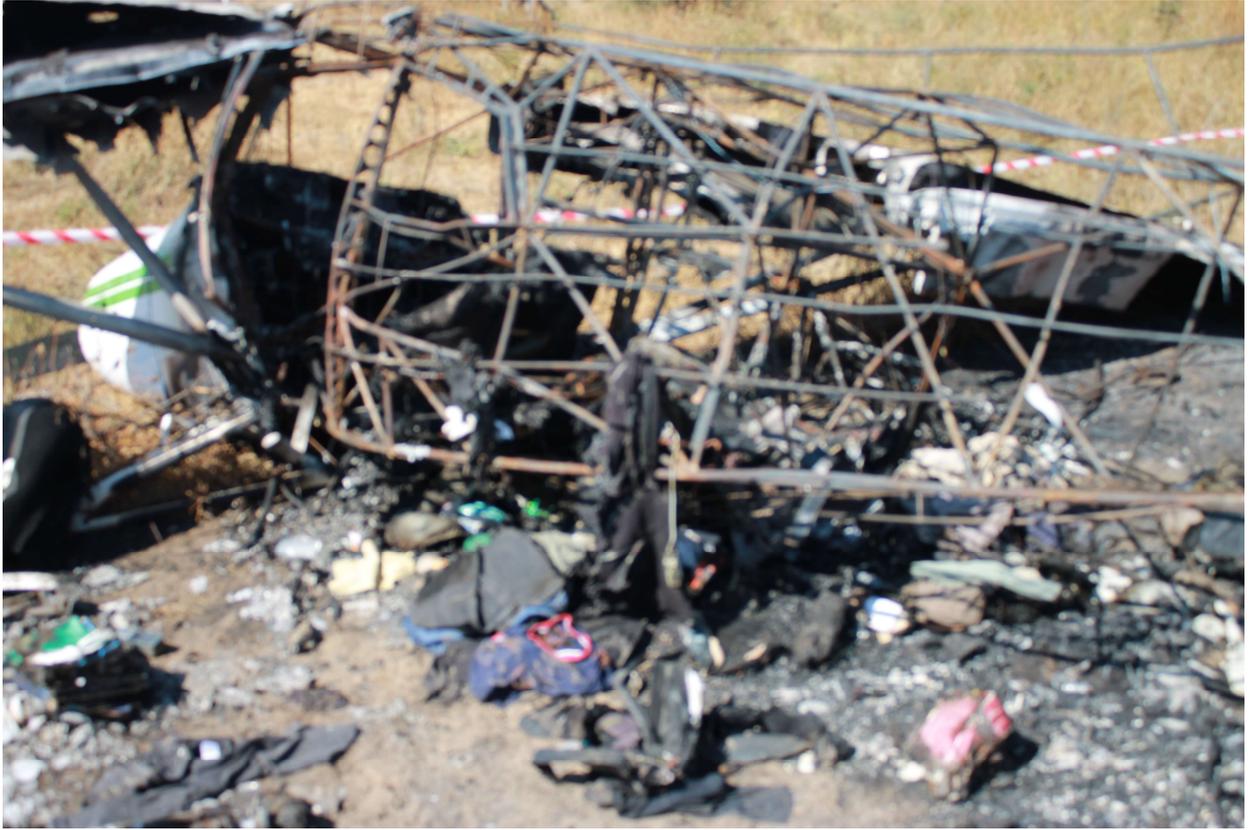
Figure 11b: The side view remnant aircraft wreckage post impact fire.
