## ACCIDENT INVESTIGATION REPORT

REPORT ON THE ACCIDENT INVESTIGATION INVOLVING A ROBINSON R44 RAVEN II HELICOPTER REGISTERED A2 – HEX THAT OCCURRED ALONG BORO RIVER (NEXT TO MAUN) ON THE 12<sup>th</sup> MARCH 2023.

### REFERENCE MTPW/AIG/08/23

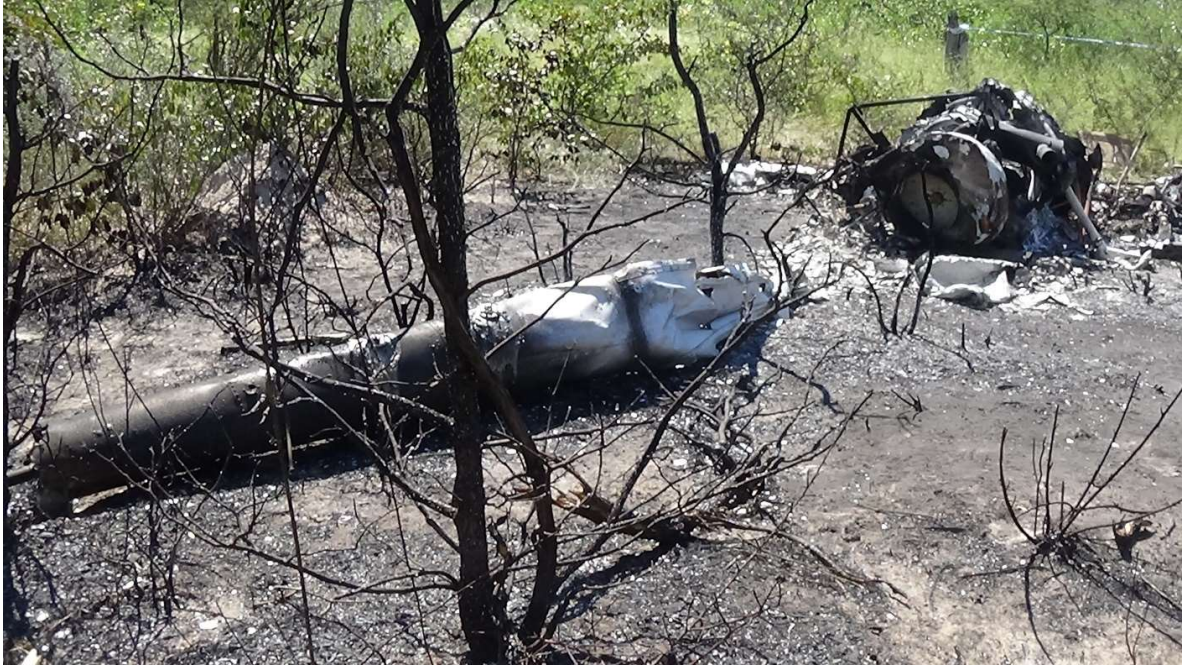
**Figure 1:** The main helicopter wreckage; tail cone assembly and remnants of fuselage with the whole canopy demised and only the engine

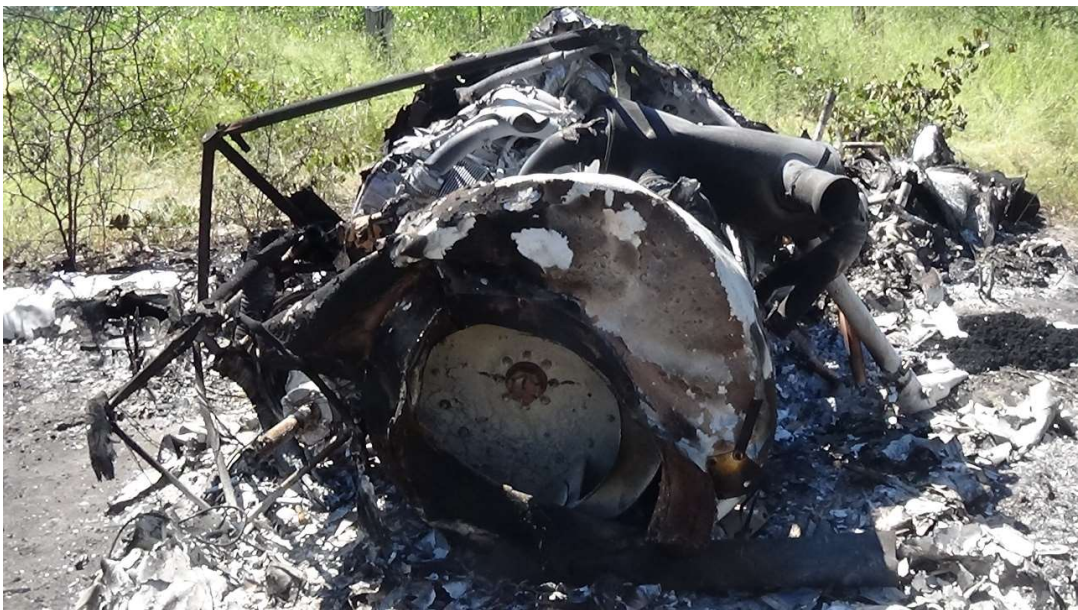
- 2.1 The engine was serviceable and normally functioning prior to the accident.
- 2.2 The main rotor drive shaft and the tail rotor drive shaft did not reveal any signs of failure whilst in service. (See **Figure 13**; para 6)

**Figure 1a:** The charred engine above is the only remaining component of the entire fuselage.

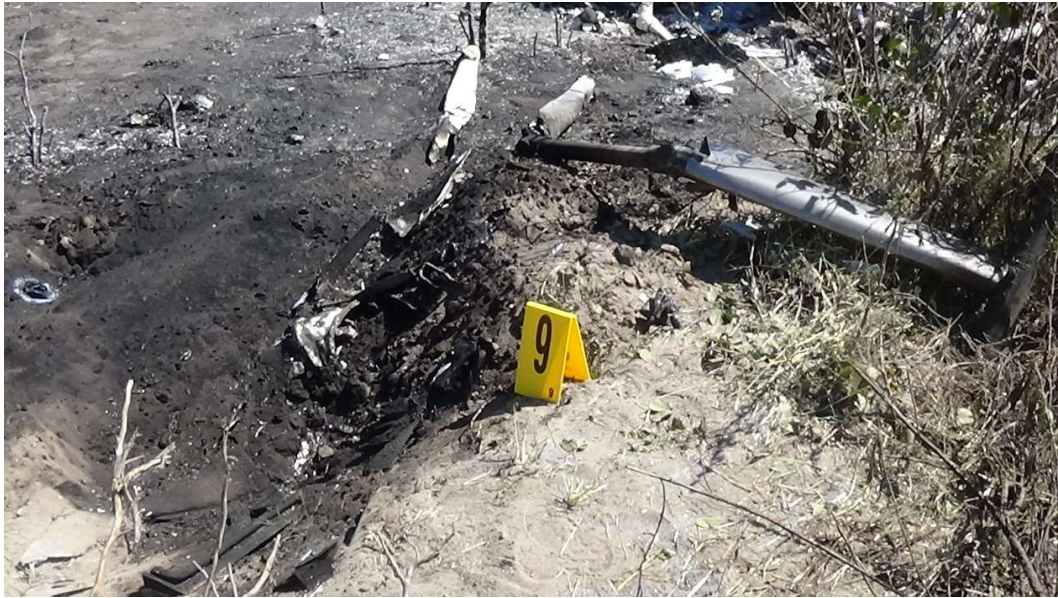
**Figure 2:** The impact point on the ground.

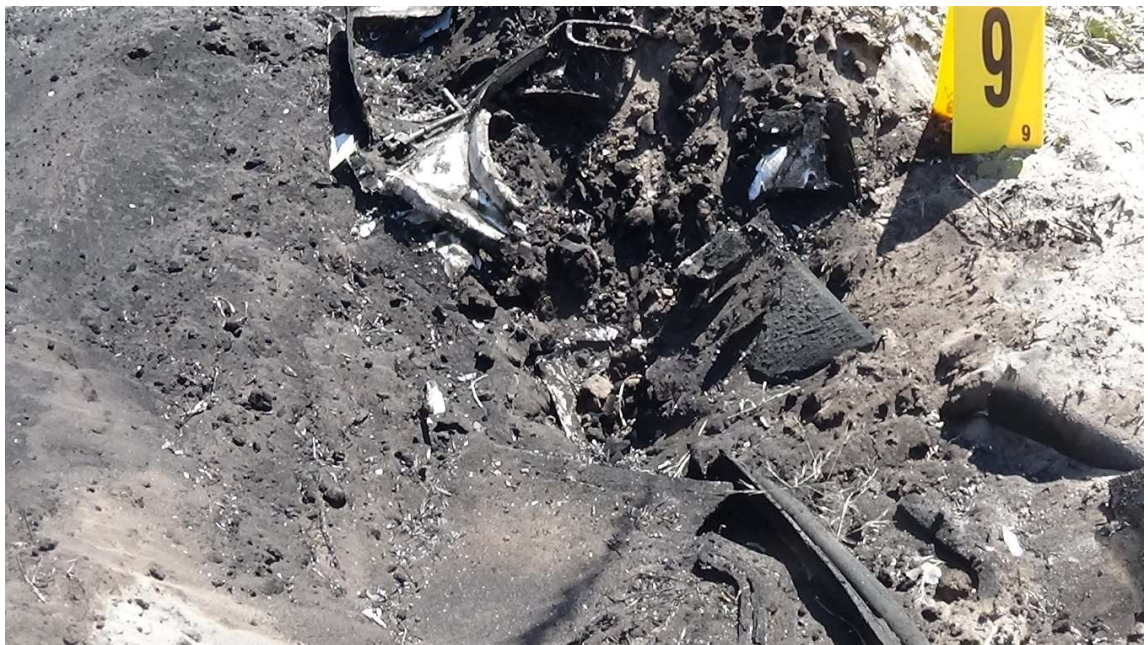
**Figure 2a:** Crater on the ground at the impact point.

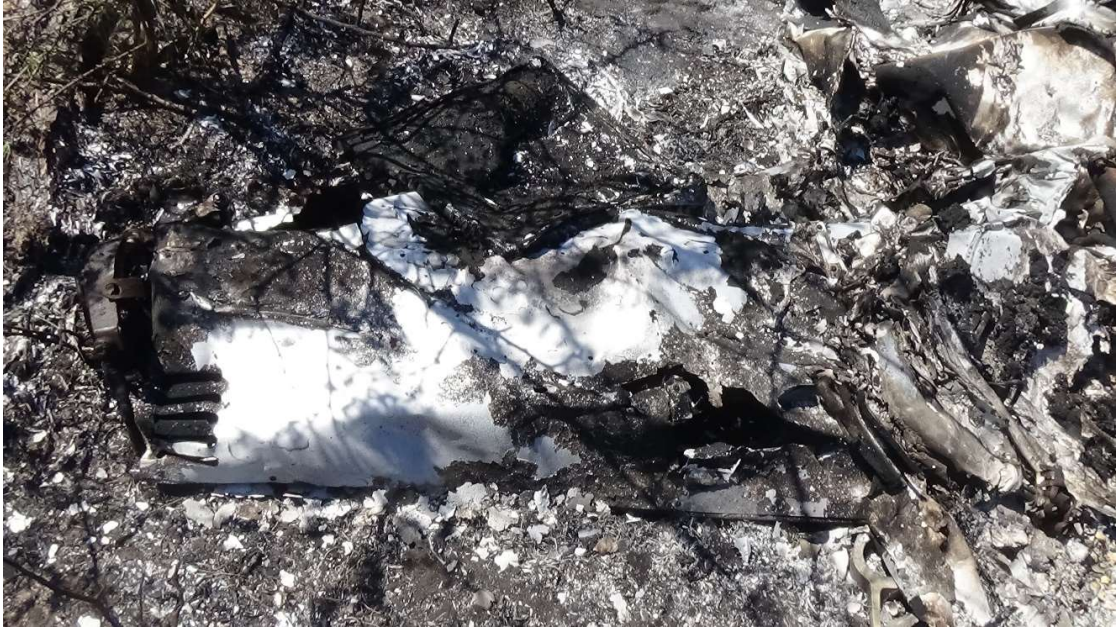
**Figure 3:** Mast fairing assembly destroyed by the post impact fire.

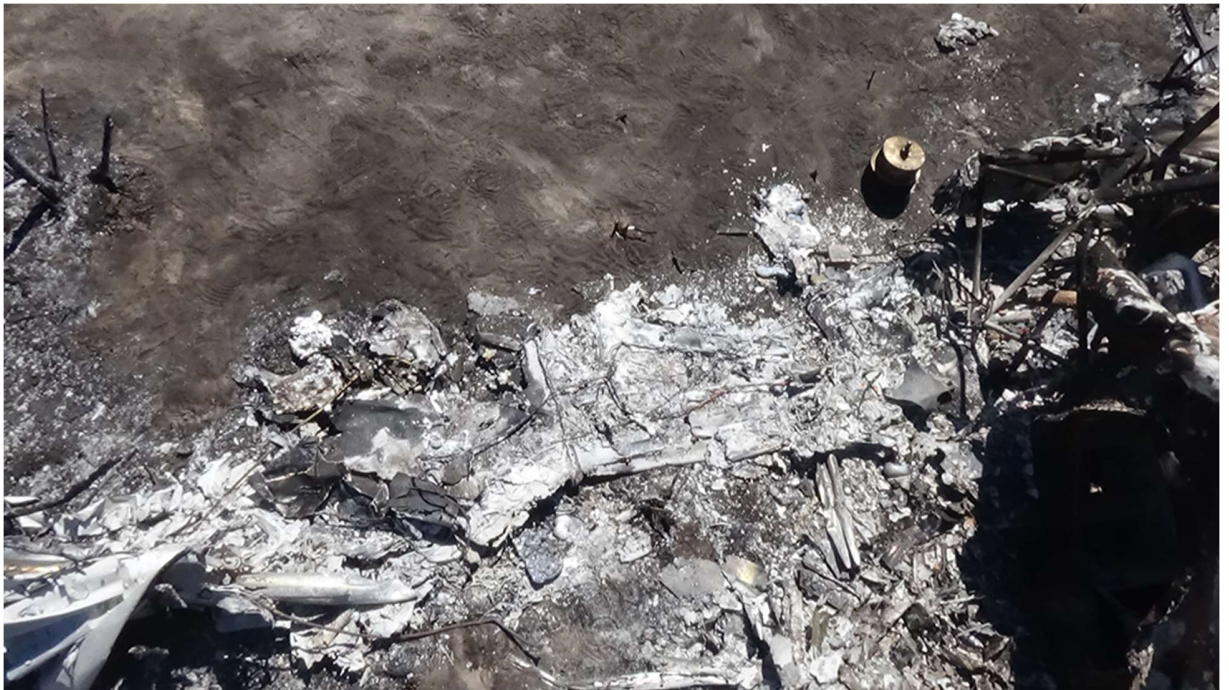
**Figure 4:** Part of the tail cone (tail cone root) melted away due to heat by post impact fire.

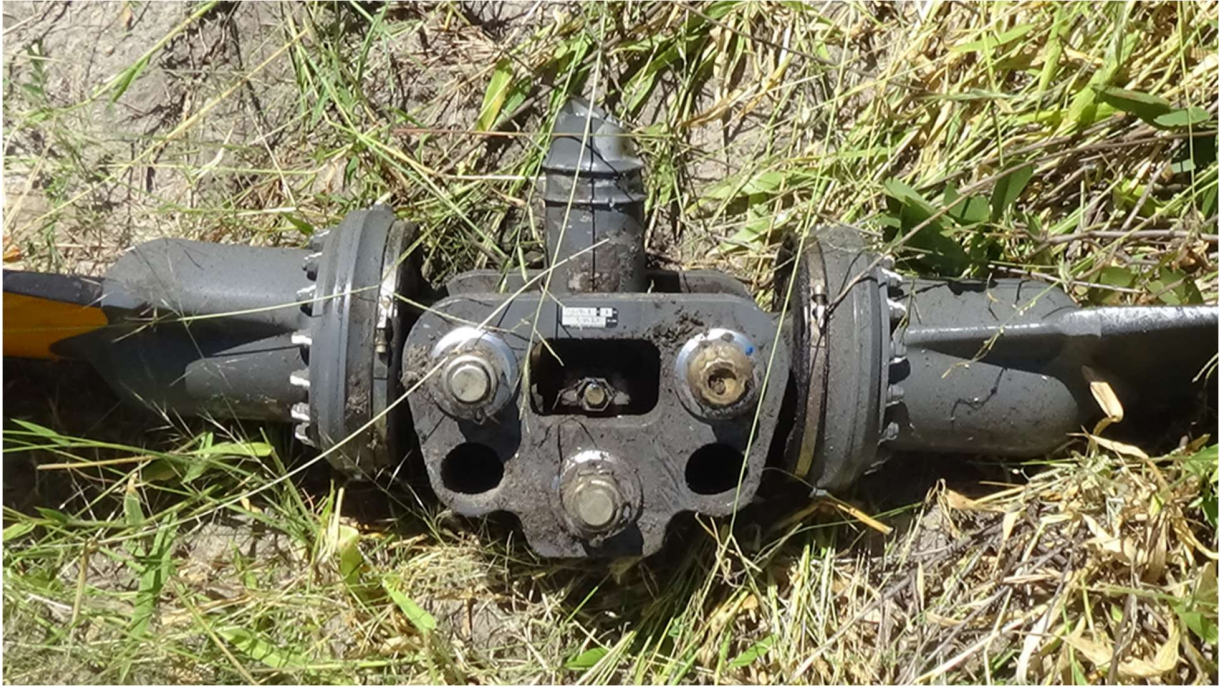
**Figure 5:** Main rotor showing breakage on the mast

3. Mast - The mast separation as in this accident, is not as common as a simple mast bump. Mast separation is a severe form of mast bump. See report fig 5. Close up photos of the mast break would be useful to see if the failure was a singular strike with the ground as noted in report para 1.12.4 or repeated strikes from damage in flight during a break up.

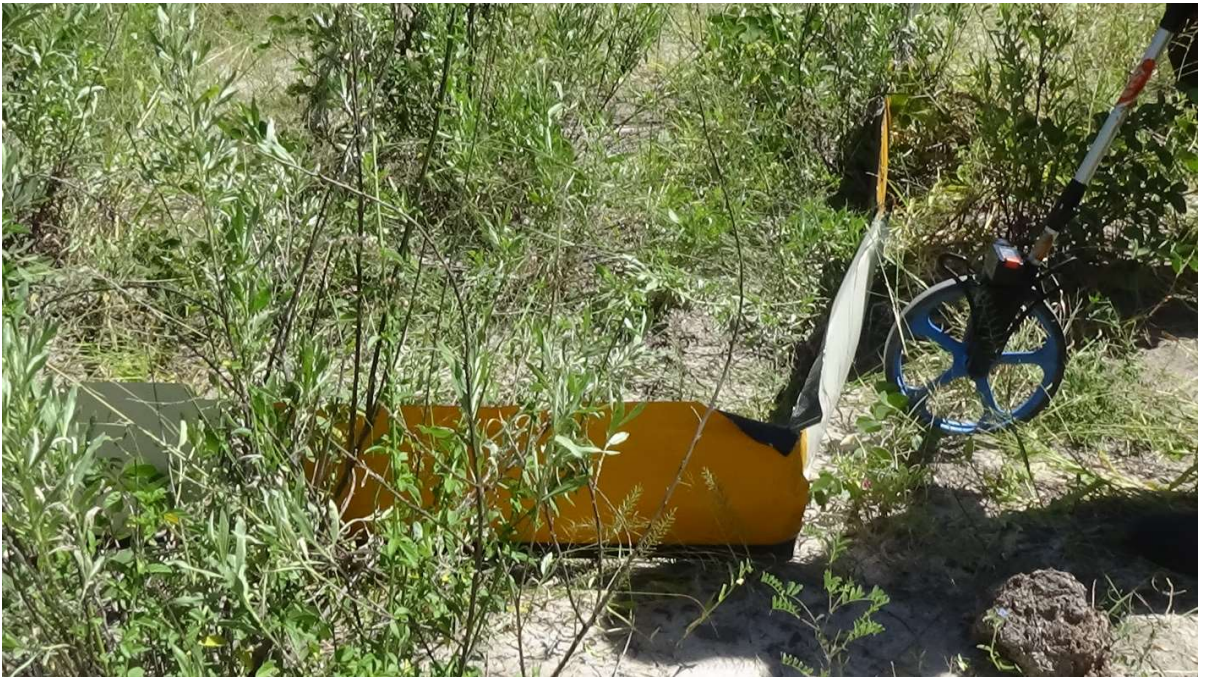
- 2.3 The main rotor blades did not show any signs of impact marks with any structural part from the onset, however after further analysis, it was discovered that they were scratches on the underside of the blades. The blades were found intact on the ground with identical bends on both blades at the tips (2metres from the tip ends). The bended blade tips did not completely detach from the main blades. (Refer to **Figure 13**; para 6)

**Figure 6:** Main rotor blades still attached to rotor assembly hub but with this perpendicular bend on both blades.

4. Main Rotor Blades - The bending of the main rotor blades noted at report para 2.3 and fig 6 exhibit low energy in the blades. Low energy is when the blades are not being driven by the engine or auto rotation. If a successful auto rotation is not entered into, the main blades will continue to slow down in flight, thus becoming low in energy. A power on strike would have blades bending backwards under power. A mast separation would have allowed the blades to lose their energy before striking the ground.

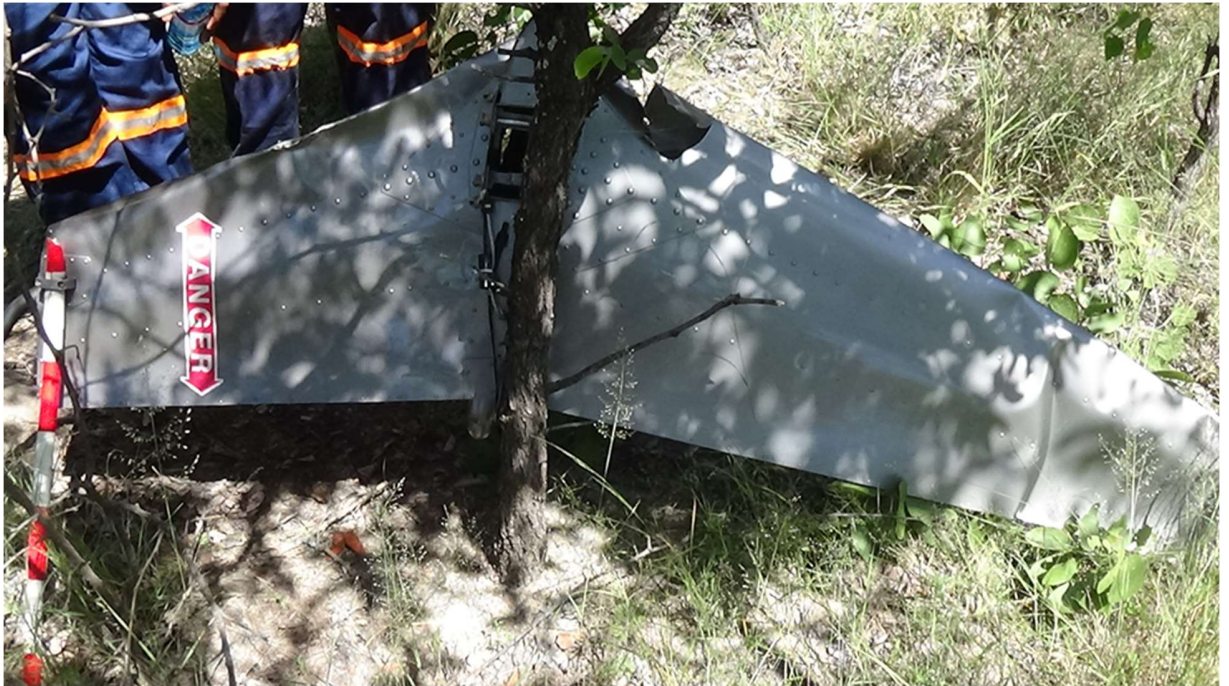
**Figure 7:** Tail end vertical stabilizer as found along the flight path.

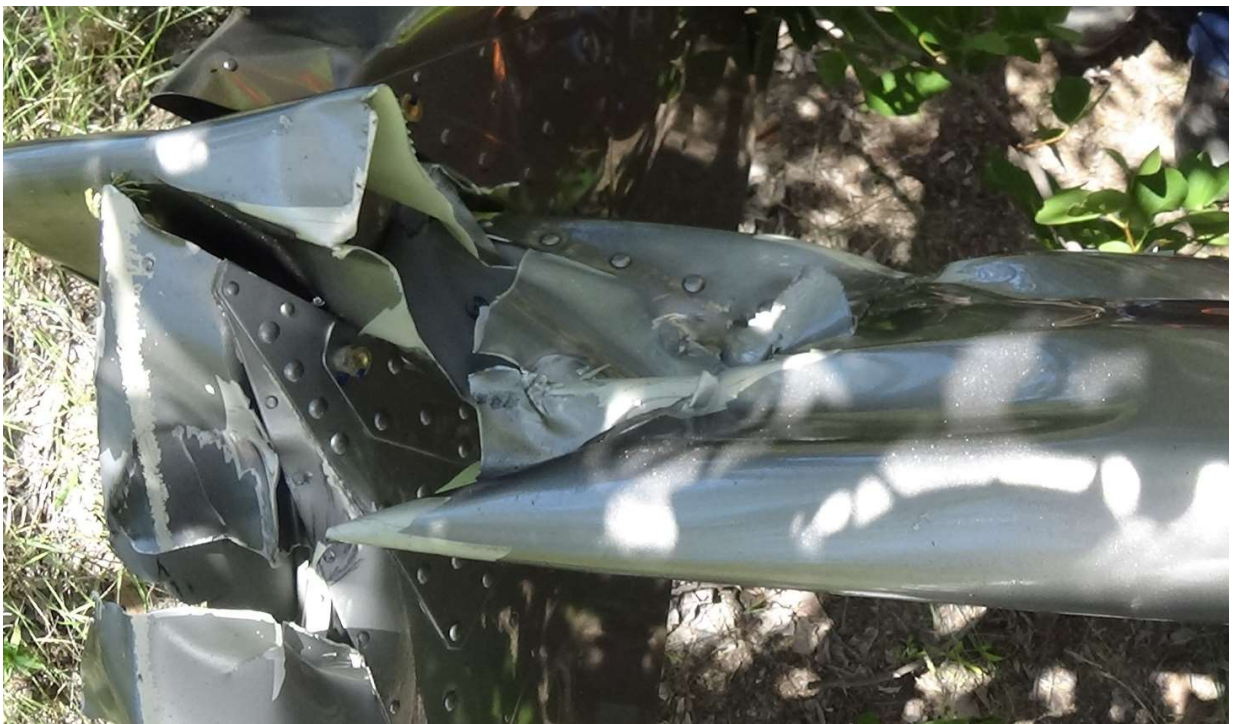
- 3.2 The damaged tail rotor blades caused an imbalance which might have led to the tail rotor gearbox tearing from the mount on the tail cone.
- 3.3 The tail rotor gear-box got disintegrated from the tail and it is suspected that as it separated, it chopped off the tail boom from the helicopter, damaging the both horizontal and vertical stabilizers along the way.

**Figure 8:** Damage on top of the tail cone that is suspected to be caused by tail rotor gear-box.

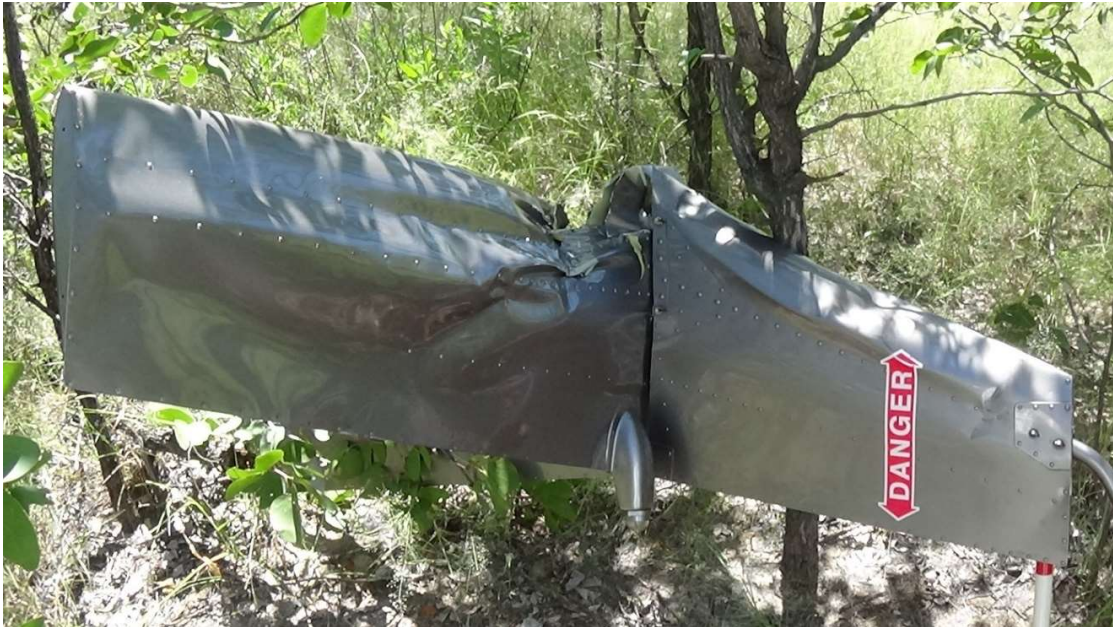
**Figure 8a:** Damage on the horizontal stabilizer

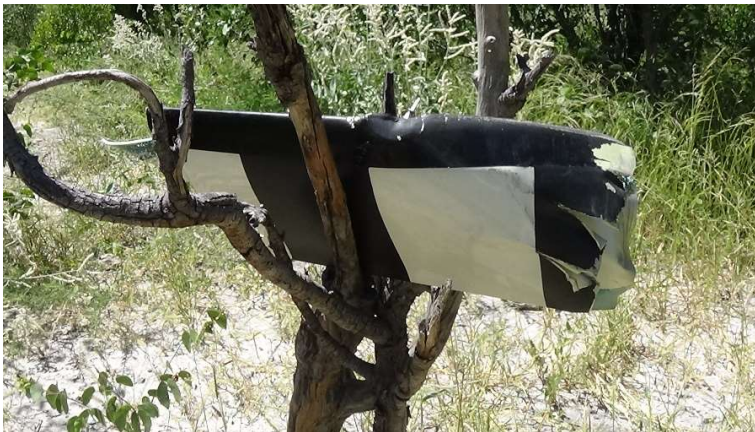
- 1.12.10 Shredded pieces of the tail rotor blade were located along the flight path. Only three (3) pieces were spotted and they do not compose a single whole blade. The rest of the tail rotor blade pieces were not found.

**Figure 9:** The largest of the only two tail rotor blade fragments that were located.

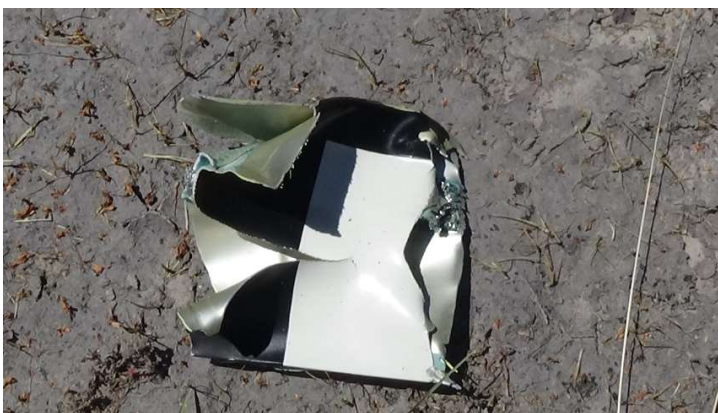
**Figure 9a:** The smallest of the two pieces of the tail rotor blade located

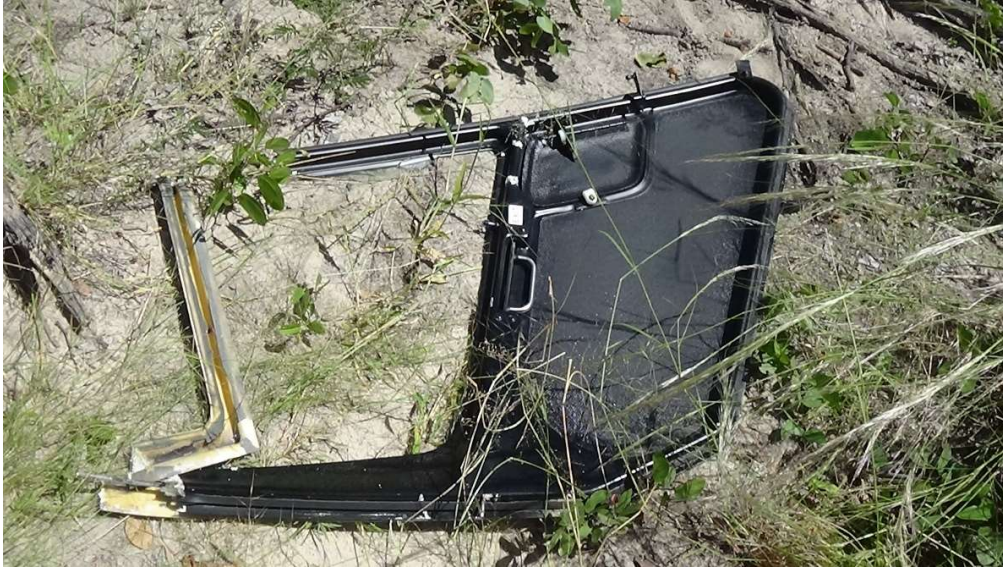
- 2.5 All the pieces of the three doors that were found on the ground showed signs of being struck by a thin object. The recovered pieces of the doors exhibited imprints (marks) of a thin material at the breakage points (contact

**Figure 10:** A rear door found along the flight path.

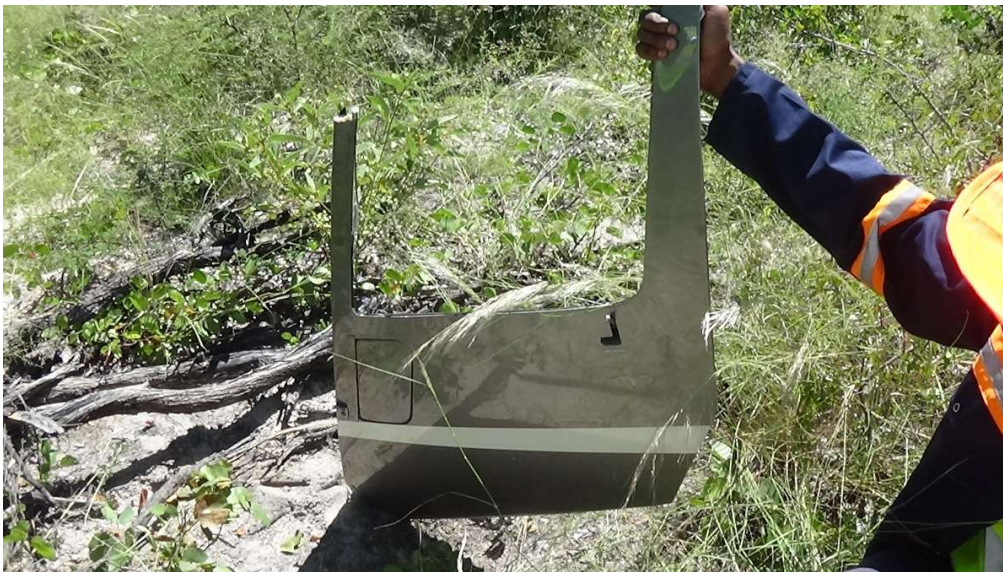
**Figure 10a:** The view of left rear door from the outside.

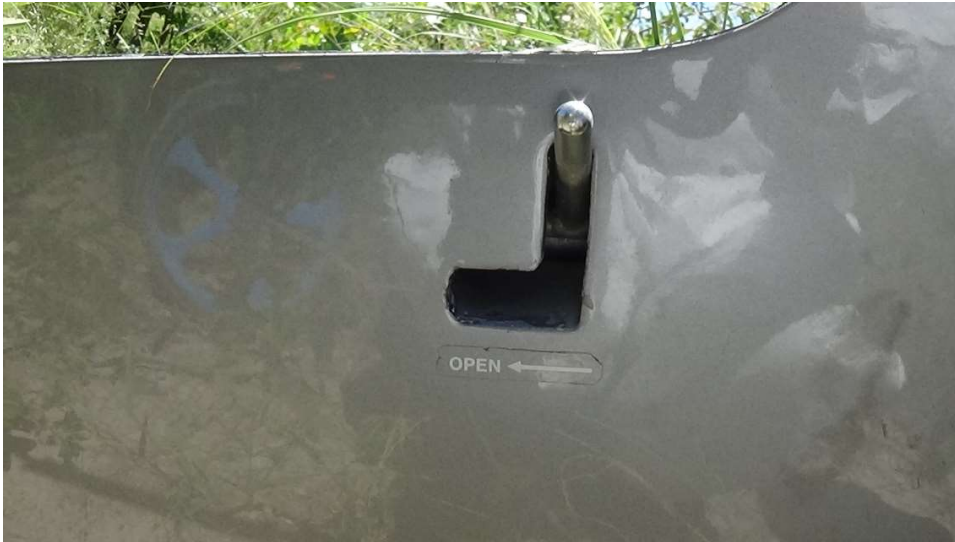
**Figure 10b:** Position of the door locking mechanism as found on the rear left door.

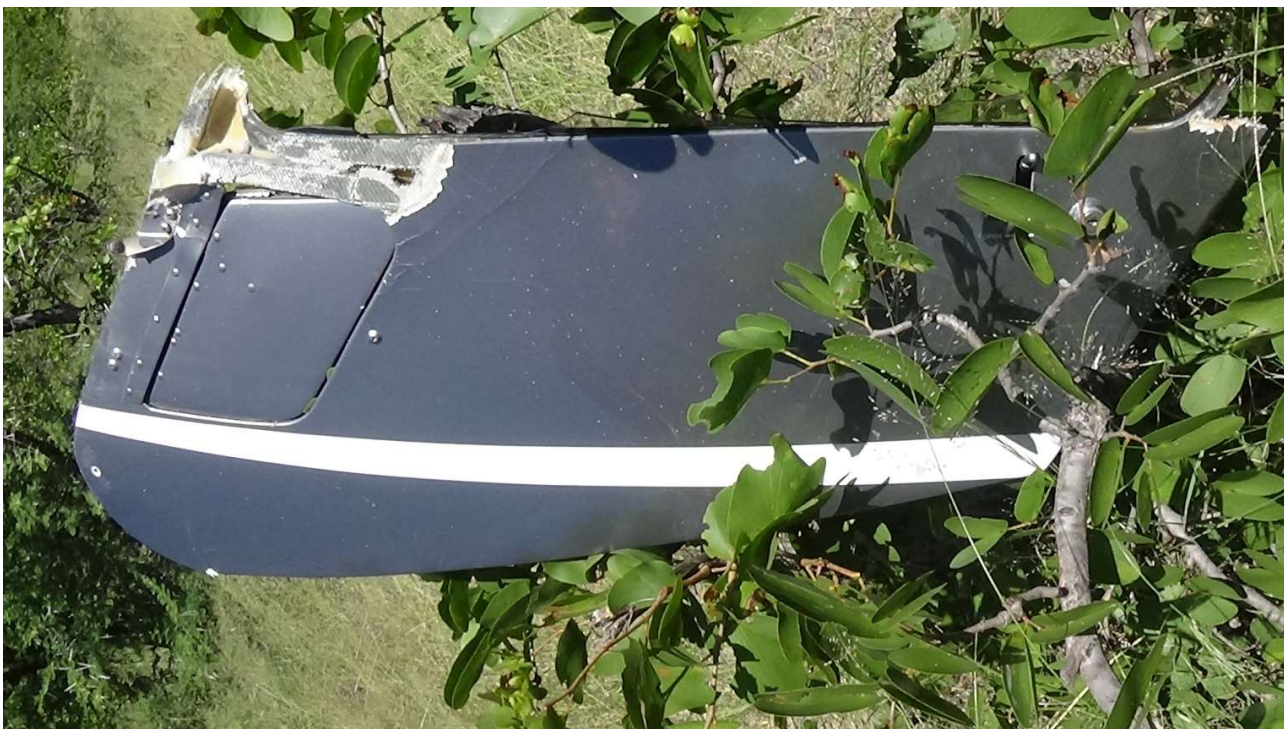
**Figure 11:** A piece of the left front door as found along the flight path. Note the position of the door locking mechanism.

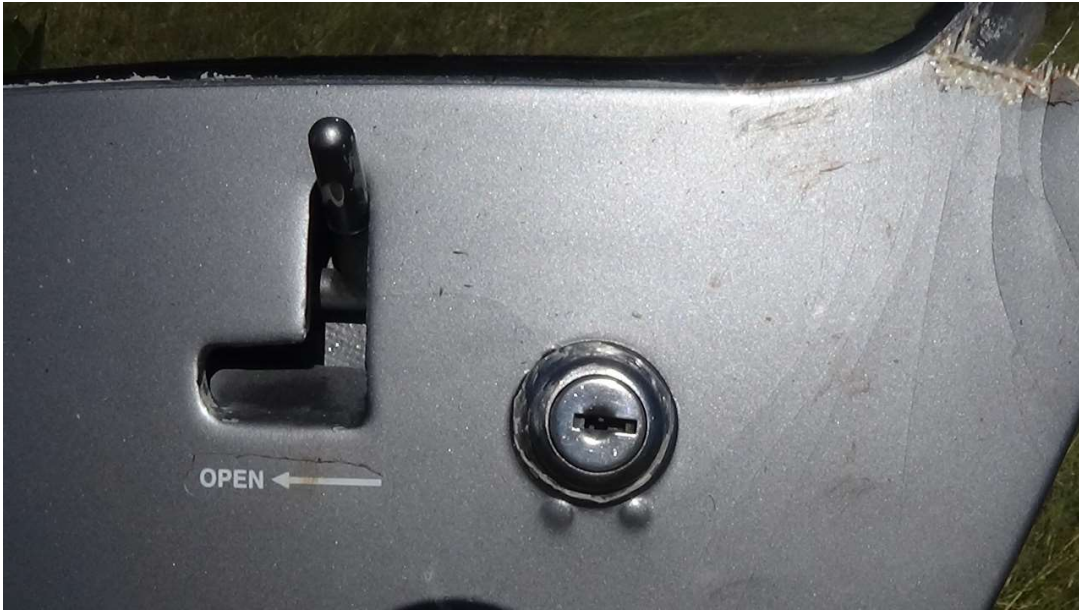
**Figure 11a:** Closer view of the left front door as found at the scene of the accident.

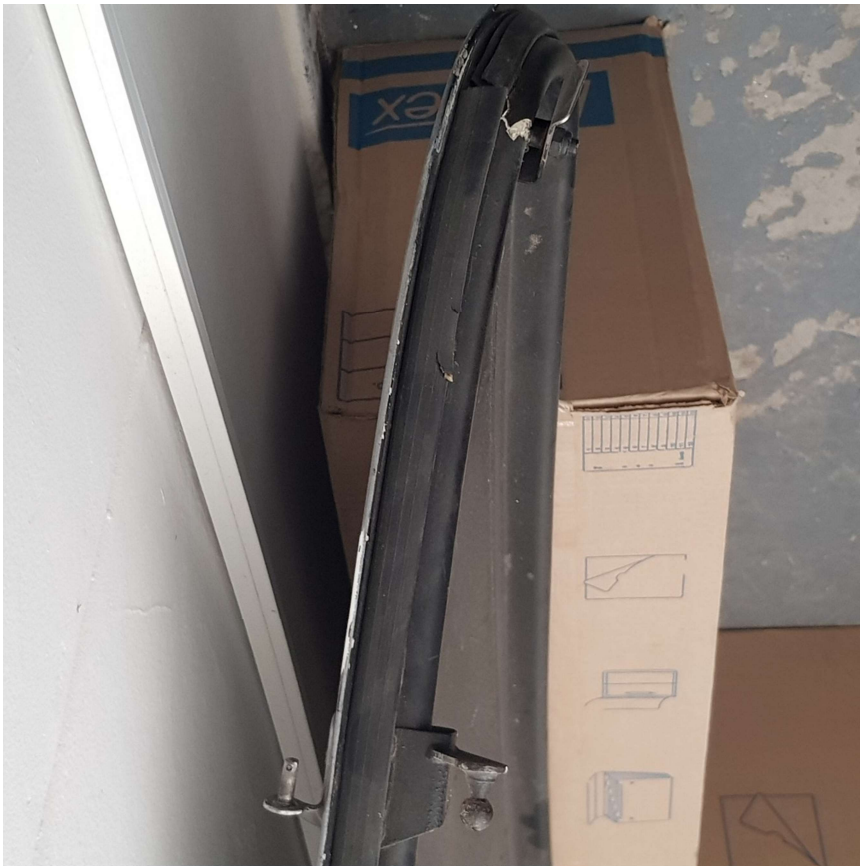
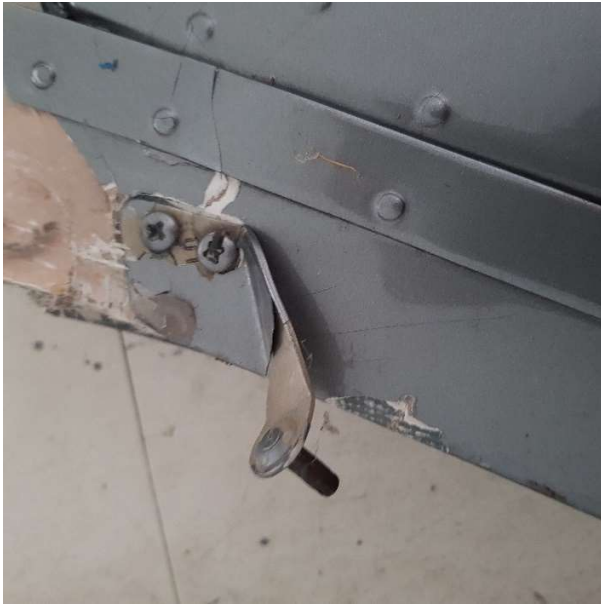
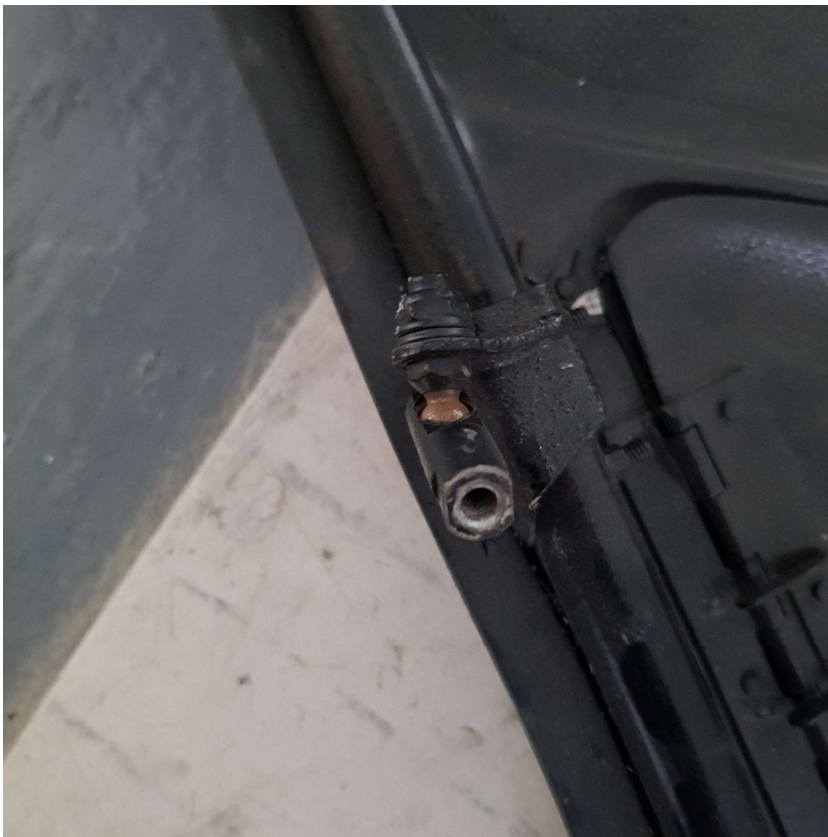
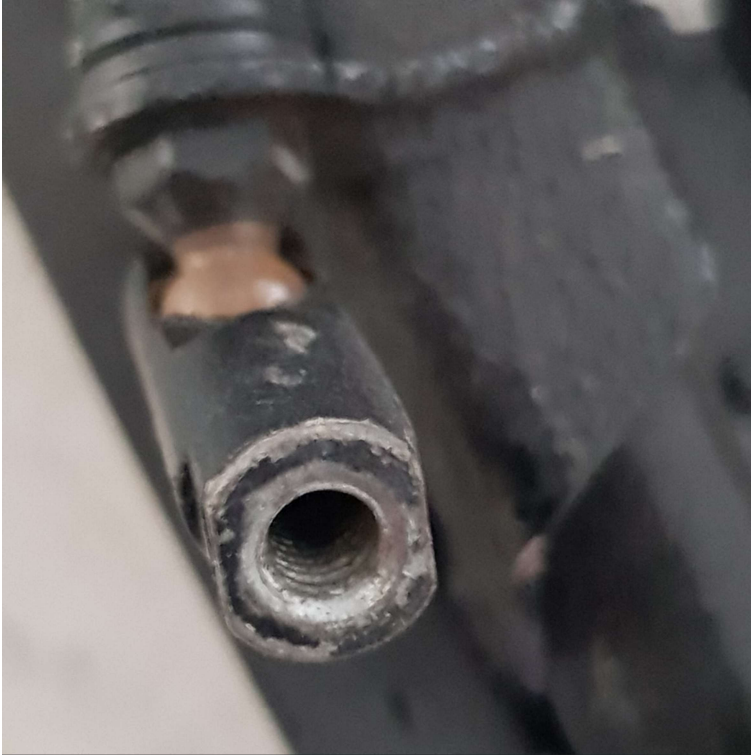
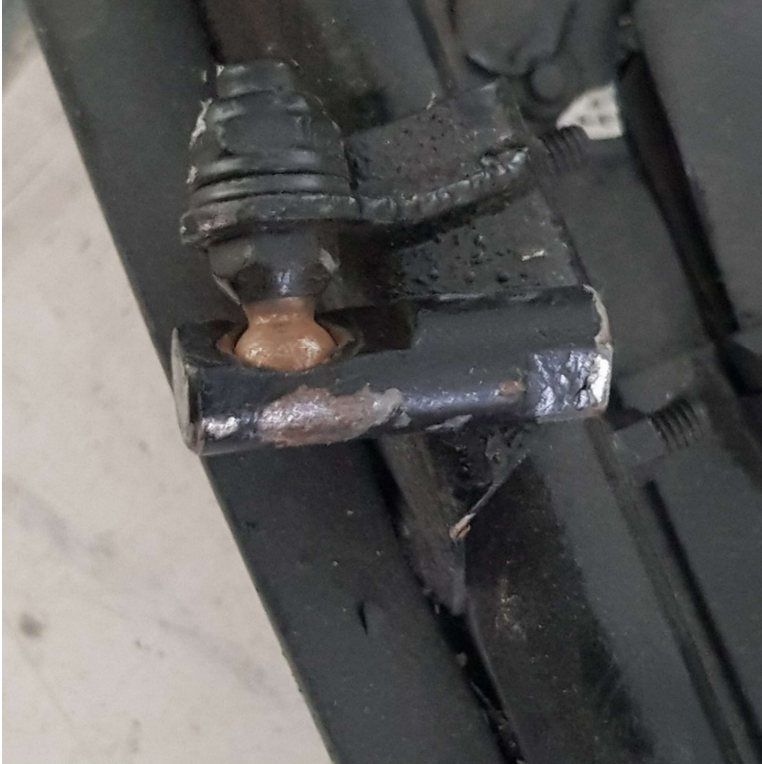
- 2.7 The door attachments components that were inspected did not provide conclusive evidence of whether there was failure in their operation or not.
- 2.8 *Door attachments hinges are shown to have holes which implies that a cotter-pin or a ring is required to keep the door locked/secured into a hinge. No ring or cotter – pin was found in any of the recovered doors.*

**Figure 11b:** View of the door attachment of the rear left door.

**Figure 11c:** Attachment component (lower door hinge) front left door.

**Figure 11d:** Frontal view of the door attachment linkage component

**Figure 11e:** Closer view of the door attachment linking component

**Figure 11f:** Side view of the door attachment linkage

- 4.3 It is recommended that the aircraft operator must place emphasis on inspection for integrity of the door attachment components during the process of door removing and fitting for off-door operation purposes.

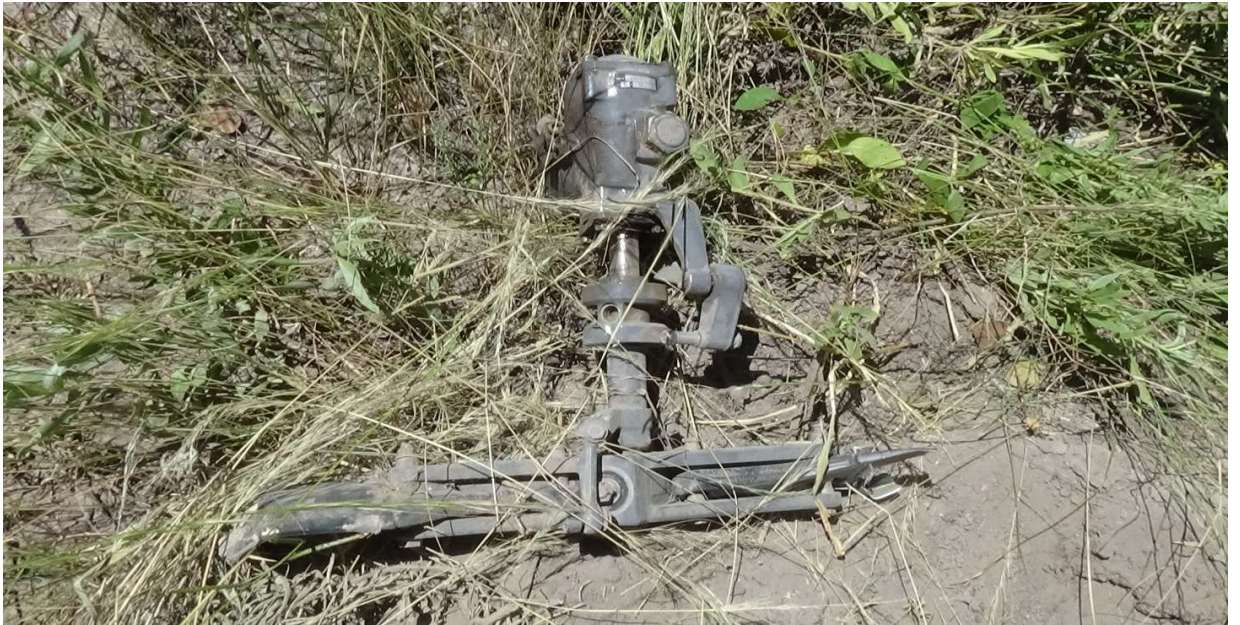
- 1.12.8 The empennage was found to be without the tail rotor gear box assembly. After some concerted search effort in the bush, the tail rotor gear box was found a distance of thirty – seven (37m) adjacent to the main wreckage.

- 1.12.9 The tail rotor gearbox was located in a straight line relative to where the empennage was found. After being detached from the helicopter structure, the tail rotor gearbox continued on a straight path. The main structure appeared to bank at a steep angle to the right where it ended up impacting the ground.

**Figure 12a:** The detached tail rotor gear-box as found at the accident scene

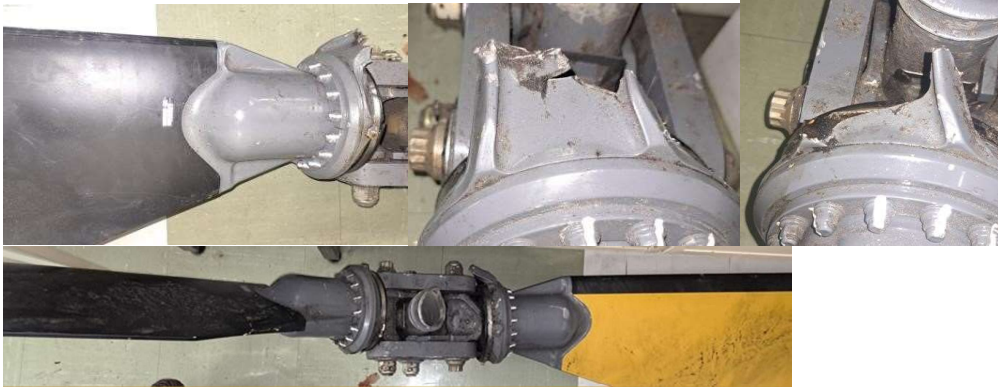
The visual- and low-magnification inspection (Photo 2; Diagram 1) revealed no clear indications of debonding, pre-impact fracture initiation/s, FOD and/or other discrepancies that could be considered contributory to the accident sequence of events (SoE). The noted damages could be related to a combination of impact and interference with the tail boom structure during the accident SoE. Both pitch horns revealed single overload fractures (Photo 2; Diagram 1, blue arrow).

Photo 2: MR blades, as supplied (Digital)

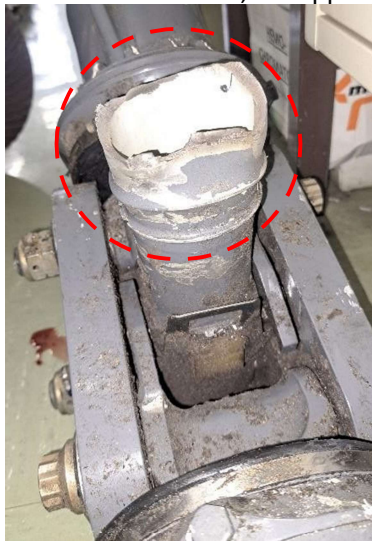
The visual- and low-magnification inspection of the MR Hub assembly (Photo 3; Diagram 2) revealed no clear indications of pre-impact failure/s or other discrepancies that could be considered contributory to the accident sequence of events (SoE).

Photo 3: MR Hub assembly, as supplied (Digital)

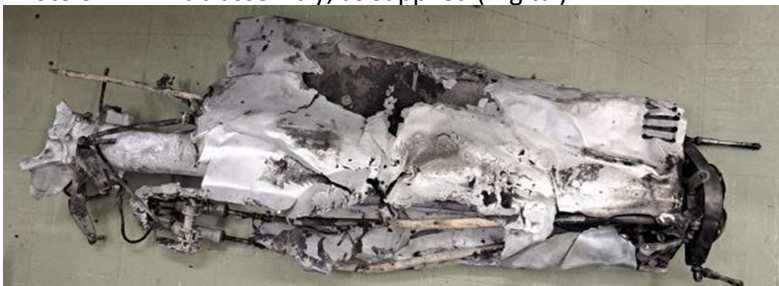
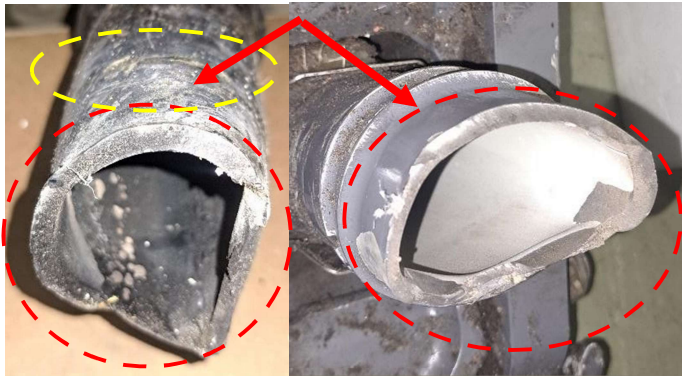
The MR Driveshaft (Diagram 3, red arrow) failed close to the MR Hub assembly (Photos 3 and 4, red dashed circles). The disparity between the paint discoloring (induced by the post-impact fire) and the noted rotational surface marks (Photo 4, yellow dashed circle) of the MR Hub end when compared to the MR Driveshaft end (Photo 4, red arrows) suggest that the MR Hub end driveshaft section separated from the bottom driveshaft section during the accident SoE. This could be attributed to severe imbalance (out of track) of the MR system during the accident SoE. This imbalance could have been introduced by (i) the pilot input/s and/or (ii) following the impact with the tail boom structure and/or (iii) due to the separation of the tail boom structure during the accident and/or (iv) impact of the MR blades with ground. The fracture geometry correlates with applied excessive torsional- and bending loads. *The former suggest that the fracture was induced while under power, however it could not conclusively be determined if the applied torsional load was due to engine- or MR inertia loads.*

Photo 4: MR drive (mast) assembly, as supplied (Digital)

Photo 4: MR Driveshaft primary fracture location (Digital)

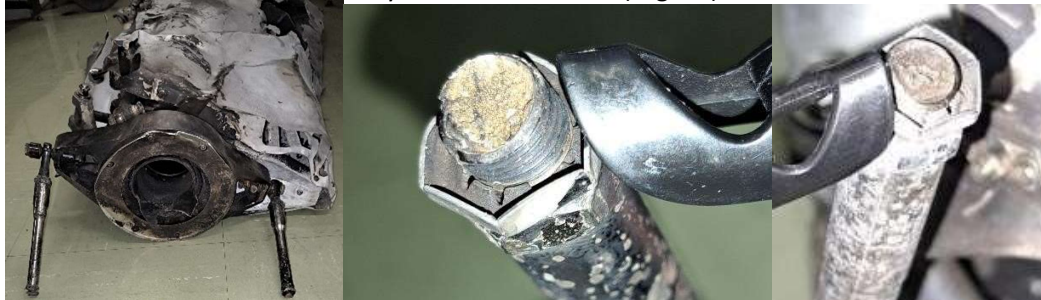
The MR Pitch Control Links (PCL) revealed fractures within the threaded sections (Photo 5) with no clear indications of pre-impact fracture initiation/s.

Photo 5: MR Pitch Control Links, fracture locations (Digital)

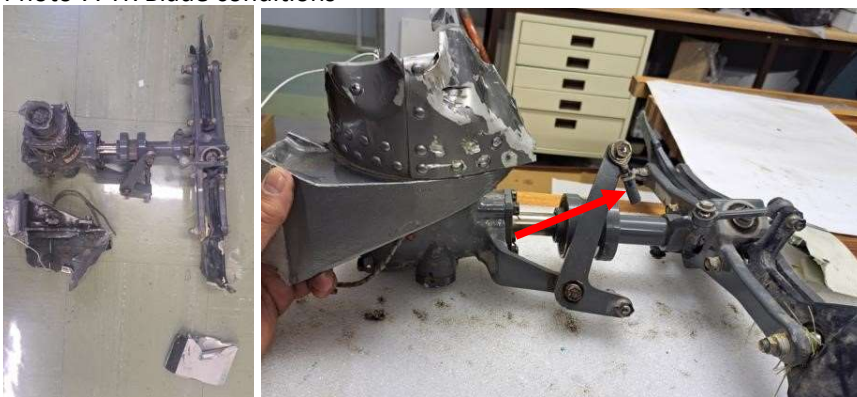
The Single-piece (elastomer bearing) TR Hub assembly revealed no clear indications of preimpact discrepancies other than the fractured push-pull tube assembly (Photo 8, red arrow; Diagram 5, red arrow). The fracture surface revealed no clear indications of pre-existing initiation/s and/or other discrepancies.

Photo 8: Single -piece TR assembly, as supplied (Digital)

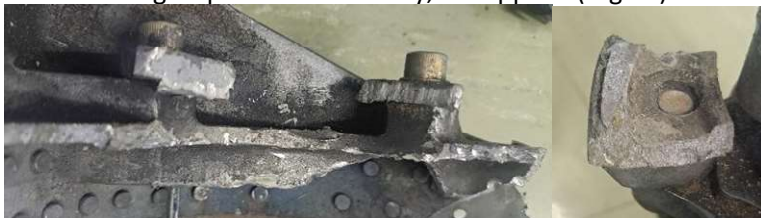
The TR Gearbox attachment points (Diagram 5) fractured at various locations during the accident SoE (Photo 9). The fracture surface morphologies and geometries correspond with an overload condition attributable to the SoE.

Photo 9: TR Gearbox fractures (Digital)

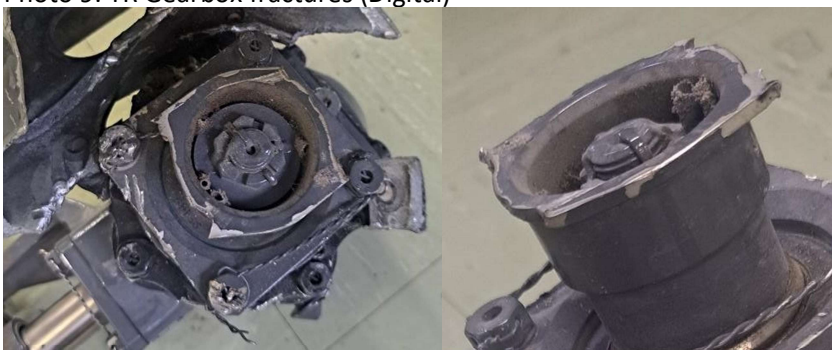
The TR Driveshaft failed at the aft yoke (Photo 10; Diagram 5, blue arrow) from the rear flex plate assembly. The fracture surface geometry and morphology suggest a bending-overload condition while under rotation. This correlates with reported separation of the aft tail boom structure during the accident SoE.

Photo 10: TR Driveshaft Yoke failure (Digital)

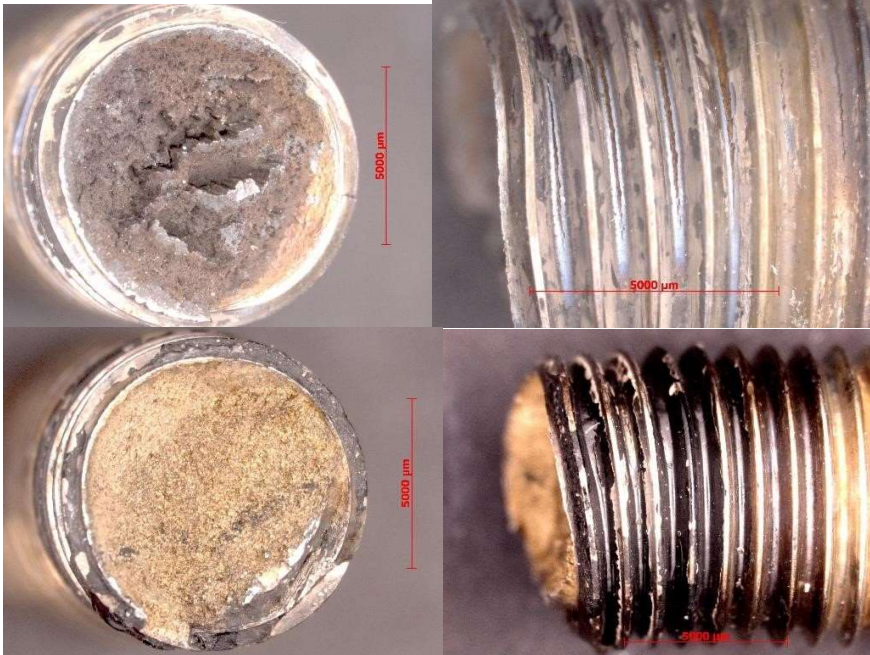
The high-magnification inspection of the PCL fracture surfaces revealed no clear indications of fatigue and/or other discrepancies (Photo 11). Secondary fracture initiations within the threaded sections confirmed exceedingly high applied bending loads applied during the accident SoE. The fracture surface morphologies are consistent with a ductile tensile overload (Fractograph 1).

Photo 11: Pitch Control Links, fracture surfaces and thread sections (Stereo)

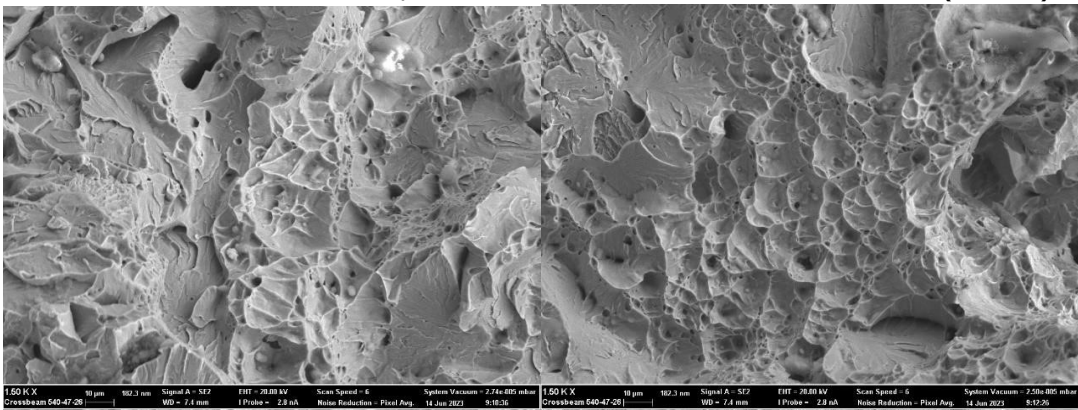
Fractograph 1: Fracture surface morphology, PCLs (1500X, FEGSEM, SE, 20kV)

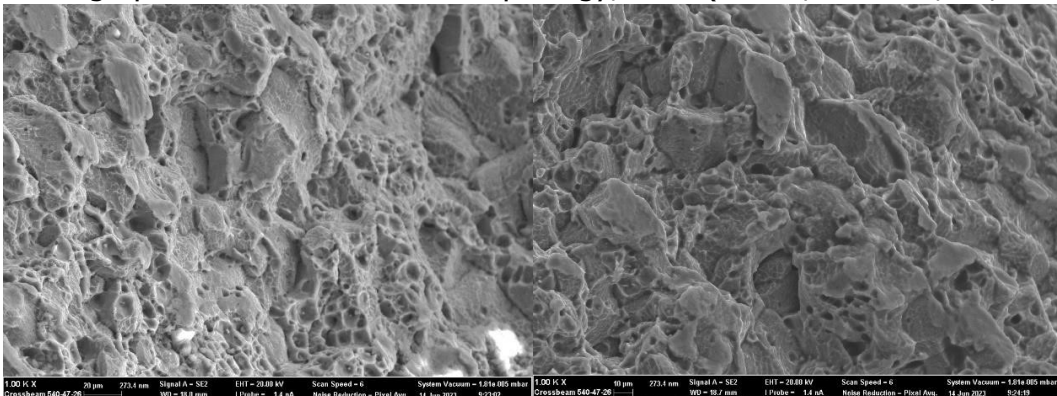
The high-magnification inspection of the Push-pull Tube fracture surface revealed no clear indications of fatigue and/or other discrepancies. The fracture surface morphology is consistent with a ductile tensile overload (Fractograph 2).

Fractograph 2: Fracture surface morphology, TR pull-push tube (1000X, FEGSEM, SE, 20kV)
