## ACCIDENT INVESTIGATION REPORT

REPORT ON THE ACCIDENT INVESTIGATION INVOLVING A ROBINSON R44 RAVEN II HELICOPTER REGISTERED A2 – HEX THAT OCCURRED ALONG BORO RIVER (NEXT TO MAUN) ON THE 12<sup>th</sup> MARCH 2023.

### REFERENCE MTPW/AIG/08/23

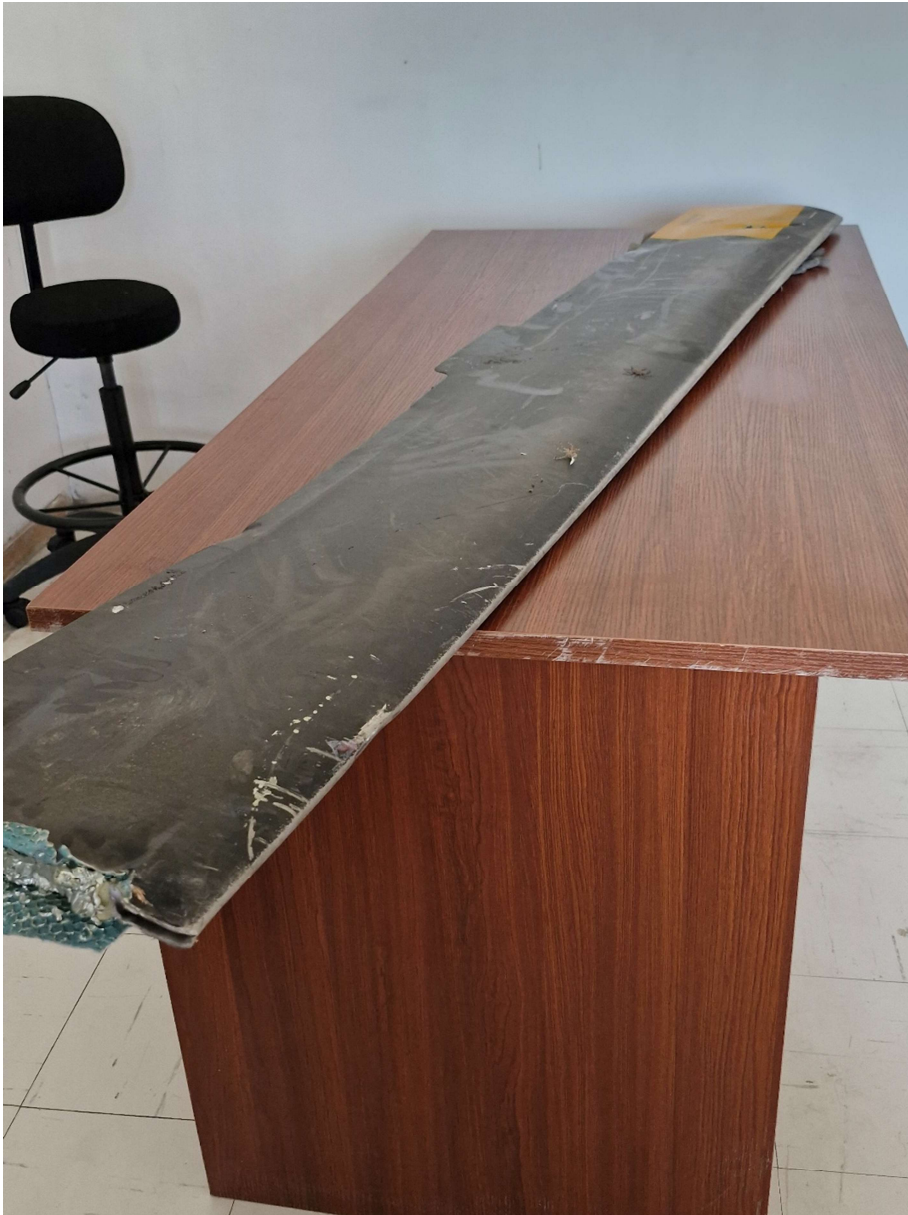
Joseph, have a look on your main rotor blades about half way along. You will see a section that looks like a cat has scratched the furniture. It is in a defined area perhaps about a meter. It is during a mast bump the blade hits the left side front windscreen and shatters the Perspex which causes the scratches on that section of blade. This supports the likelihood of a mast bump.

**Figure BB:** A2 – HEX main rotor blade with scratches similar to those attributable to contact with windows.
